Back Analysis of Mount Polley Tailing Dam Failure

Md Abdullah Al Arafat

A thesis submitted to the faculty of graduate studies

ABSTRACT

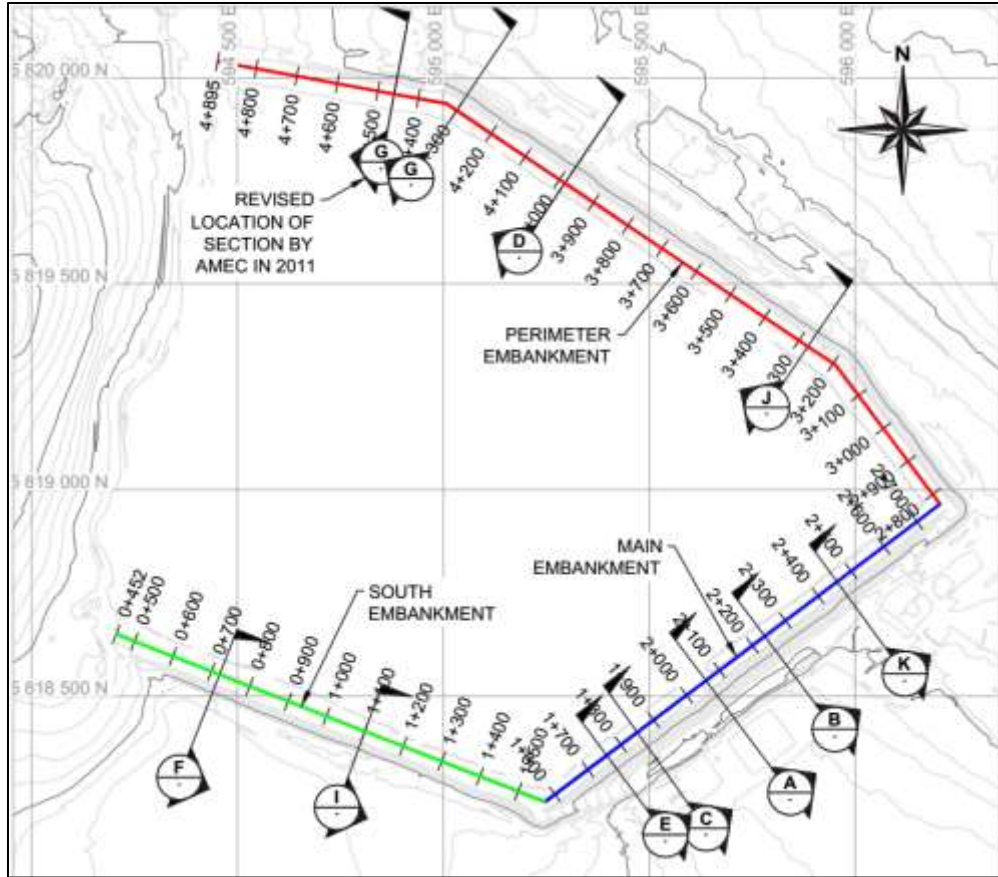
The perimeter embankment of the MP-TSF failed after the completion of 9th stage construction, between the survey stations 4+200 and 4+300 on August 4, 2014 (Figure 3). At the time of failure, the 10th stage design documents, proposing an additional 6.5 m increase in embankment height, were sent to the regulator for approval. The physical damage of the breach included sudden erosion of the dam body and toxic tailings material, which flowed towards Polley Lake, Hazeltine Creek, and Quesnel Lake. Two Google Earth images (Figure 4) clearly demonstrate the pollution caused by the failure in the nearby lakes. It was estimated that the failure released about 10.5 million cubic meter of supernatant water, 7.3 million m³ of tailing solid, 6.5 million m³ of interstitial water and 0.6 million m³ of construction materials towards downstream (Imperial Metals 2015).

Figure 3: Layout of MP-TSF (as per Morgenstern *et al.* 2015)

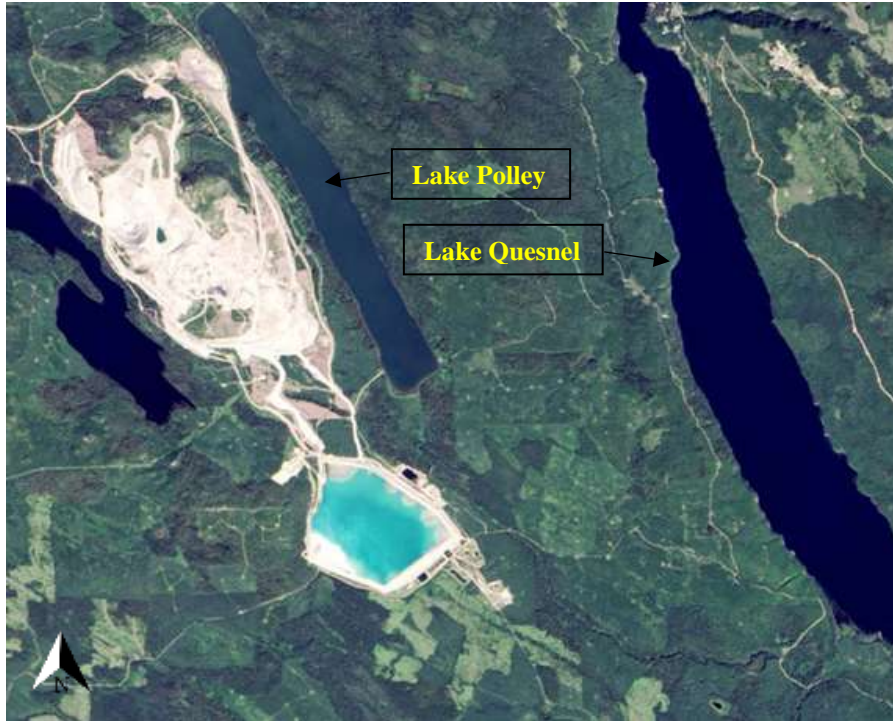
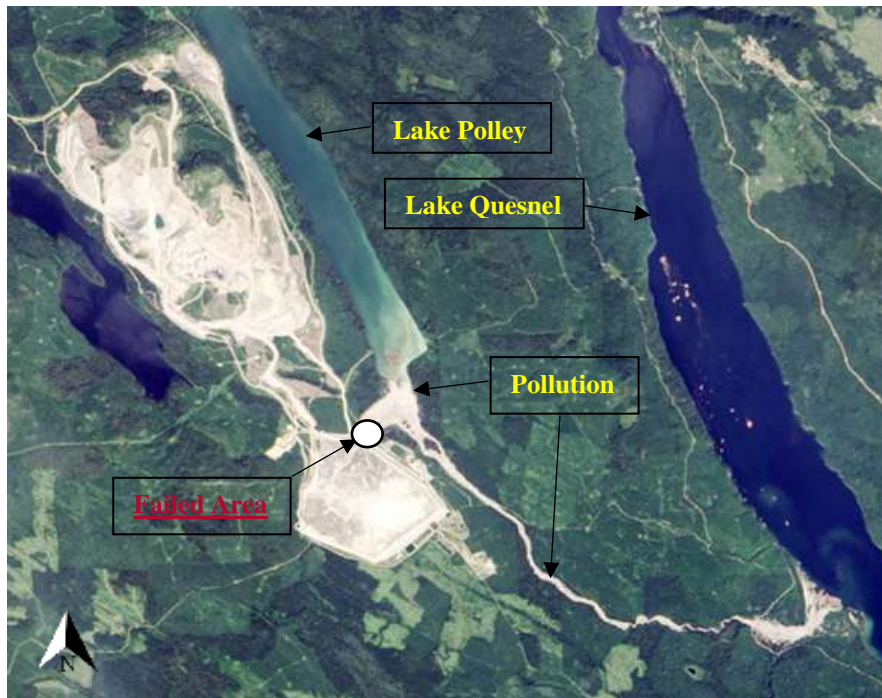
Figure 4: Google Earth images of MP-TSF before and after failure

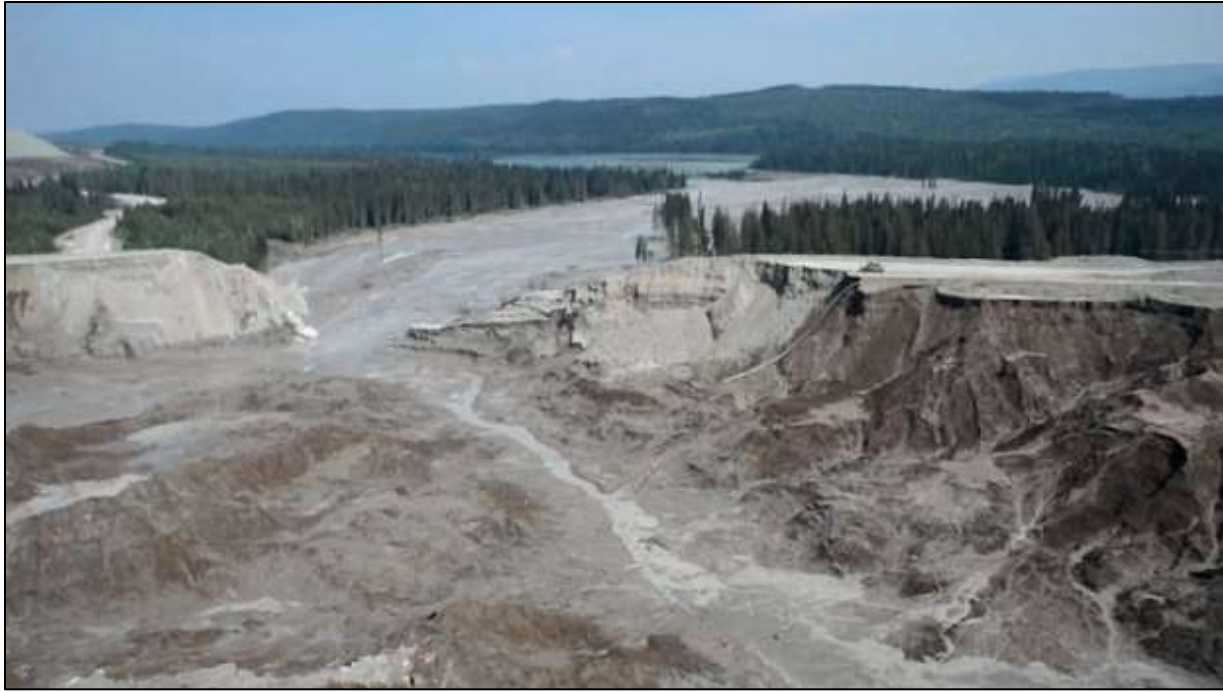
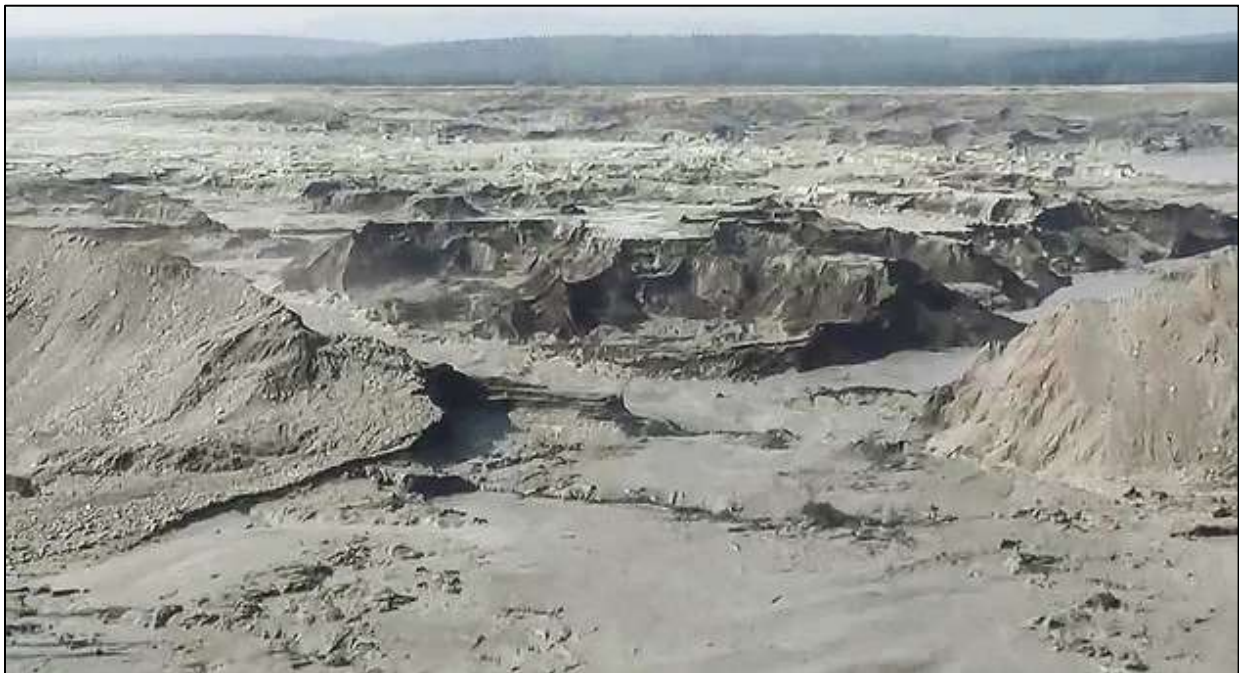
Figure 5: Post-failure images of the MP-TSF (source: Morgenstern et al. 2015)

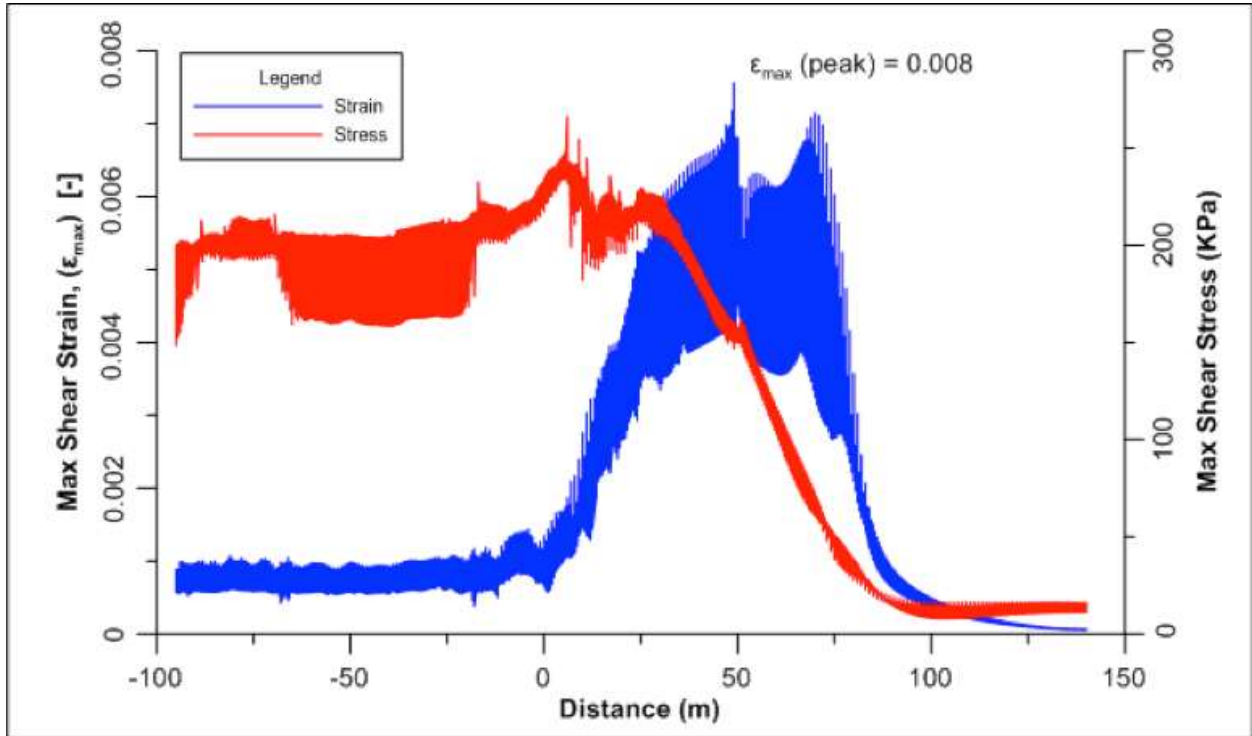
It has been shown for Case 1 (higher relative stiffness) in Figure 24 that maximum shear stress was mobilized in the section is close to 300 KPa. For this stress, the amount of shear strain was as low as 0.8%. A new layer of construction in the 9th stage (Figure 25) increased the shear stress in the system; however, it did not increase the shear strain of GLU layer. For Case 2 (lower relative stiffness), the values of shear strain were not high (2% max) and the changes in shear strain from 8th to 9th stage were marginal (Figure 26 and Figure 27).

Figure 24: Maximum Shear Strength and Strain plot for GLU in 8th stage (ESA: Case 1)

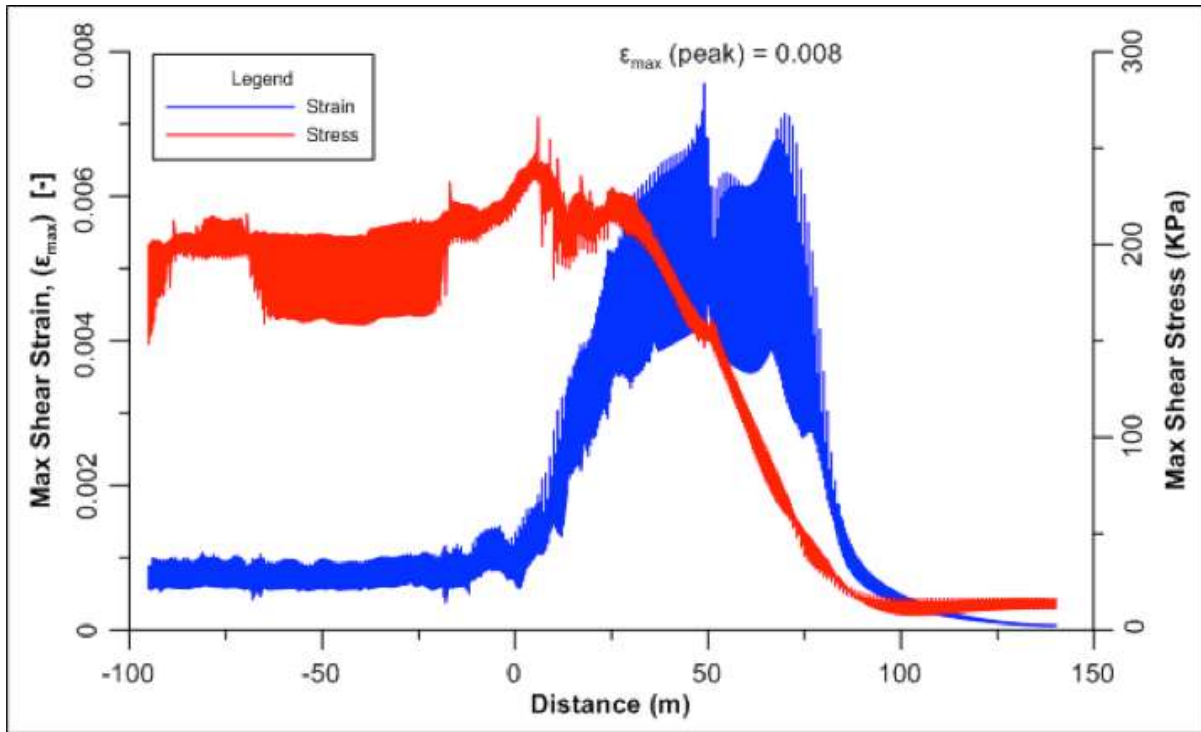
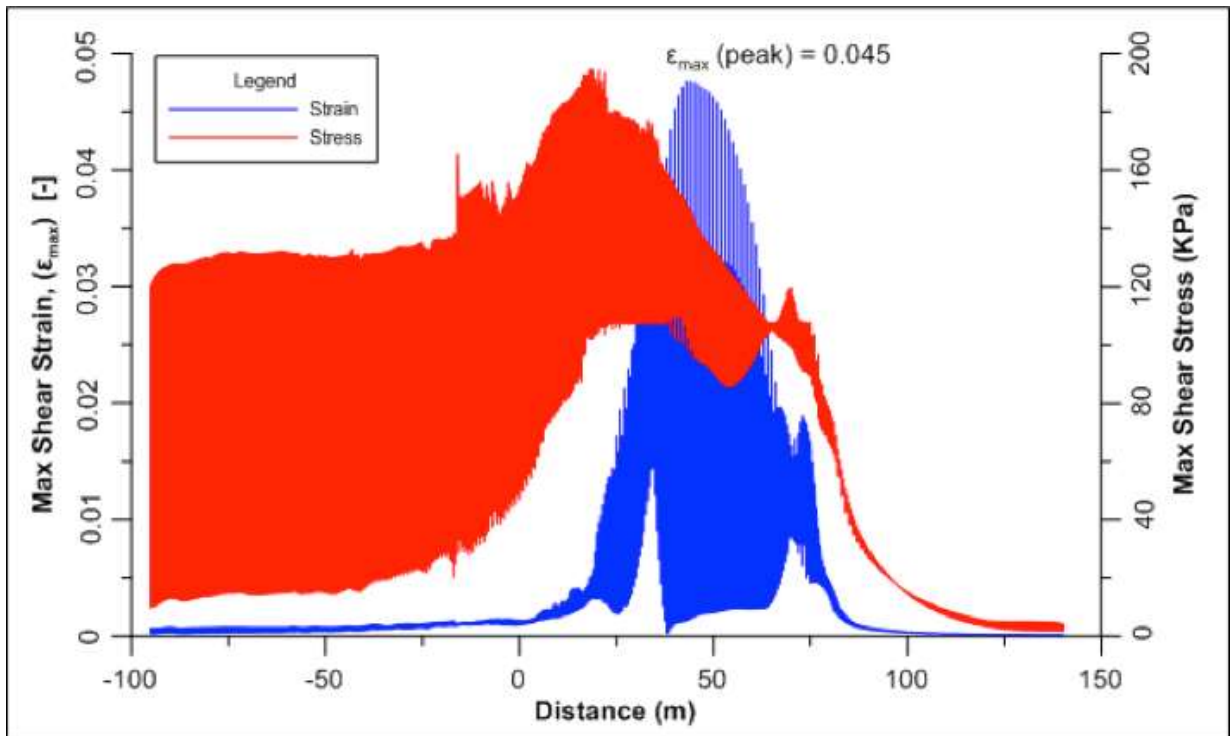
For Case 3, where the relative stiffness of the GLU layer is not very low, the maximum shear strains are 0.6% and 3% respectively for stage 8 and 9 (Figure 32 and Figure 33). These changes in shear strain is relatively high; however, the values of maximum shear strain (ϵ_{\max}) is within the acceptable limit. For case 4 with lower relative stiffness of GLU layer, the maximum shear strain (ϵ_{\max}) increased from 0.8% in 8th stage to 8% in 9th stage at mobilized shear stress around 160 KPa (Figure 36 and Figure 37). This shear strain is high enough to initiate a distortion in the system and might act as the first step in a progressive failure.

Figure 32: Maximum Shear Strength and Strain plot for GLU in 8th stage (TSA: Case 3)

Figure 33: Maximum Shear Strength and Strain plot for GLU in 9th stage (TSA: Case 3)

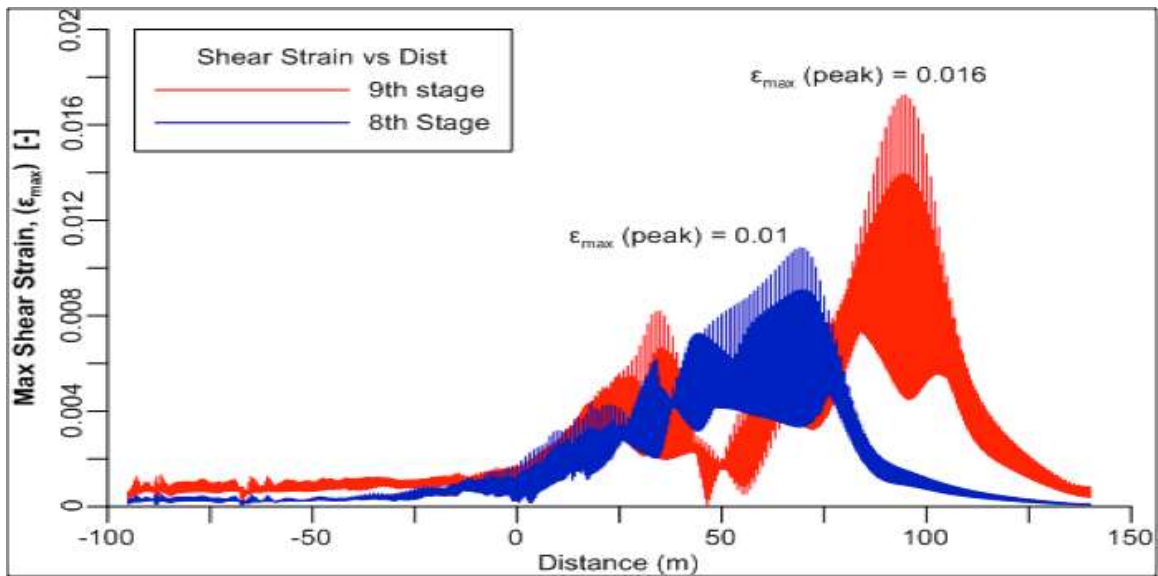
Figure 43: Maximum shear strain (ϵ_{max}) along GLU layer for 8th & 9th stage (With flattened d/s

Figure 43 shows that the maximum shear strain (ϵ_{max}) did not jump from 1.2% (8th stage) to 1.6% (9th stage). This negligible increase in shear strain indicates that if the slope were mild, the stability of the dam would improve. Further flattening of downstream slope would earn higher factor of safety.

provides resistance against slips. The factor of safety was found to be 1.20. Although, this value is less than the recommended value, it could have prevented the failure as it is considerably greater than the unity of FOS. A long-term factor of safety was calculated as 1.6 which is also greater than the recommended value. The additional calculated volume required in the dam body was approximately 380 m^3 per linear meter along the length of the perimeter dam.

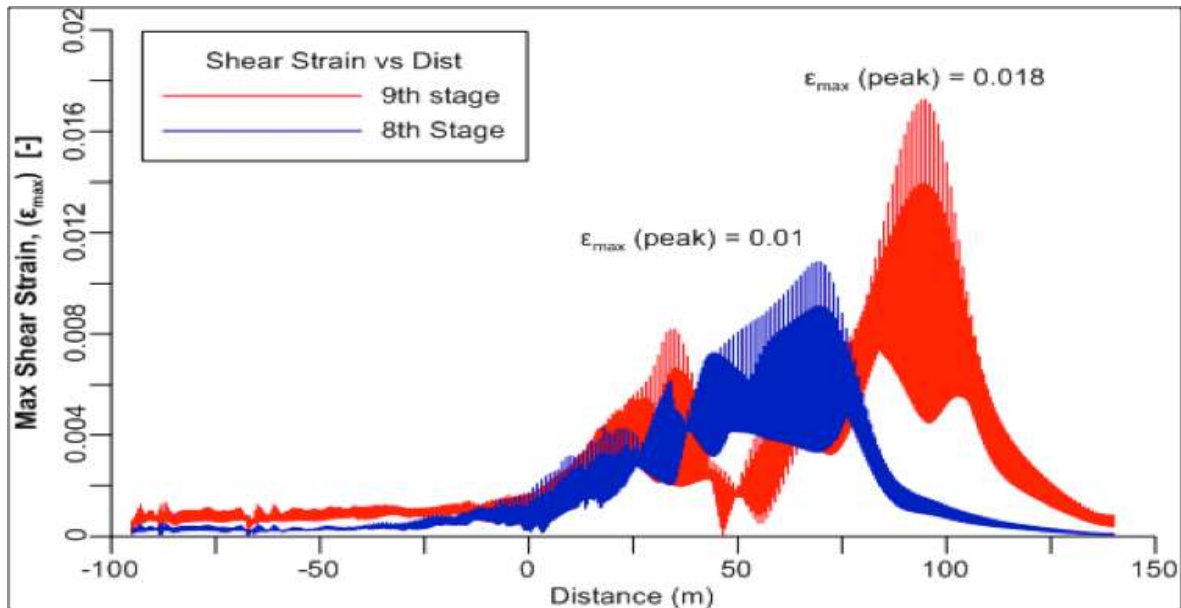
Figure 45 shows the maximum shear strain (ϵ_{max}) in stages 8 and 9 which are 1% and 1.6% respectively. The data shows that the magnitude and change in maximum shear strain (ϵ_{max}) are insignificant to initiate an instability in the dam system.

Figure 45: Maximum shear strain (ϵ_{max}) along GLU layer for 8th and 9th stage (with a new d/s berm)

Adding a berm to the downstream side of the dam increases the factors of safety. It gives lateral supports to the downstream as well as it helps to distribute the stresses over the foundation (Chowdhury *et al.* 2010). An advantage of the berm installation is that it may be used as the ‘access road’ to the dam. The berm size of 30 m x 14 m (Trapezoidal) provide increases the factor of safety up to 1.2 (Figure 44). The additional volume required in the dam body was approximately 420 m³ per linear meter.

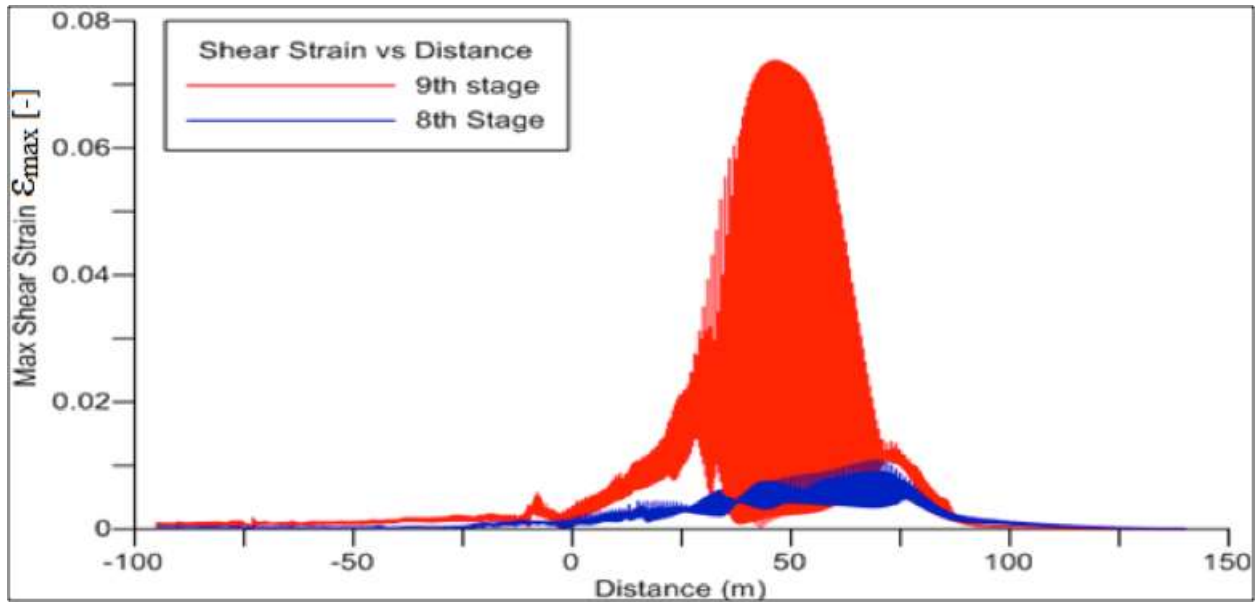
Figure 47 indicates that maximum shear strain (ϵ_{max}) jumps from 1% in 8th stage to 8% in 9th stage. This excessive shear strain in 9th stage is sufficient to allow distortion and deformation in the foundation system. The failure mechanism in this case is similar to that of the original dam section. Thus, the dam remains unstable even thickness of the core material increases.

Figure 47: Maximum shear strain (ϵ_{max}) along GLU layer for 8th and 9th stage (With widened core)
