**TESTING AND MODELLING OF A REINFORCED CONCRETE SHEAR WALL  
SUBJECTED TO COMBINED LATERAL AND AXIAL LOADING**

A THESIS SUBMITTED TO THE FACULTY OF GRADUATE STUDIES  
IN PARTIAL FULFILLMENT OF THE DEGREE  
REQUIREMENTS FOR THE DEGREE OF  
MASTER OF APPLIED SCIENCE

GRADUATE PROGRAM IN CIVIL ENGINEERING  
YORK UNIVERSITY  
TORONTO, ONTARIO

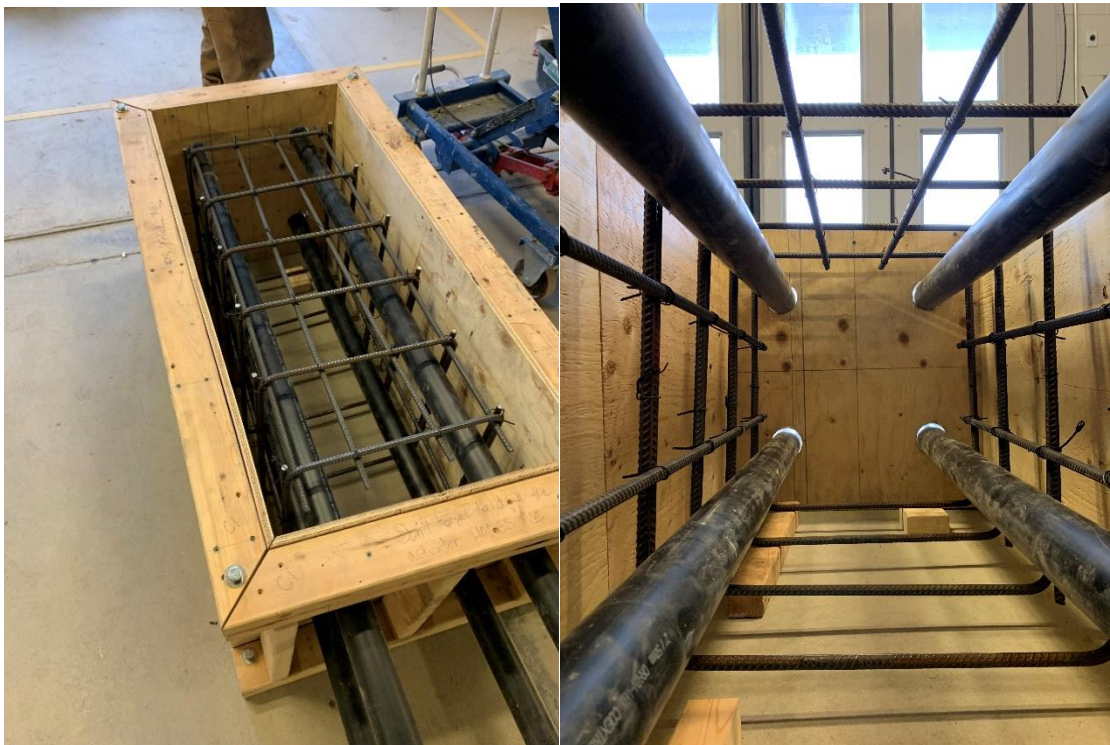
*Figure 3.8: Cap Beam Formwork and Cage*

The existing formwork was designed for a smaller cap beam, therefore, additional 2 in x 4 in timber was attached to support the change in width of the new cap beam. The cap beam was redesigned, and new formwork had to be constructed. In the new formwork, four holes were drilled at either end to allow for PVC pipe to be put in place for the threaded rods which would be secured to the horizontal actuator (see Figure 3.8).

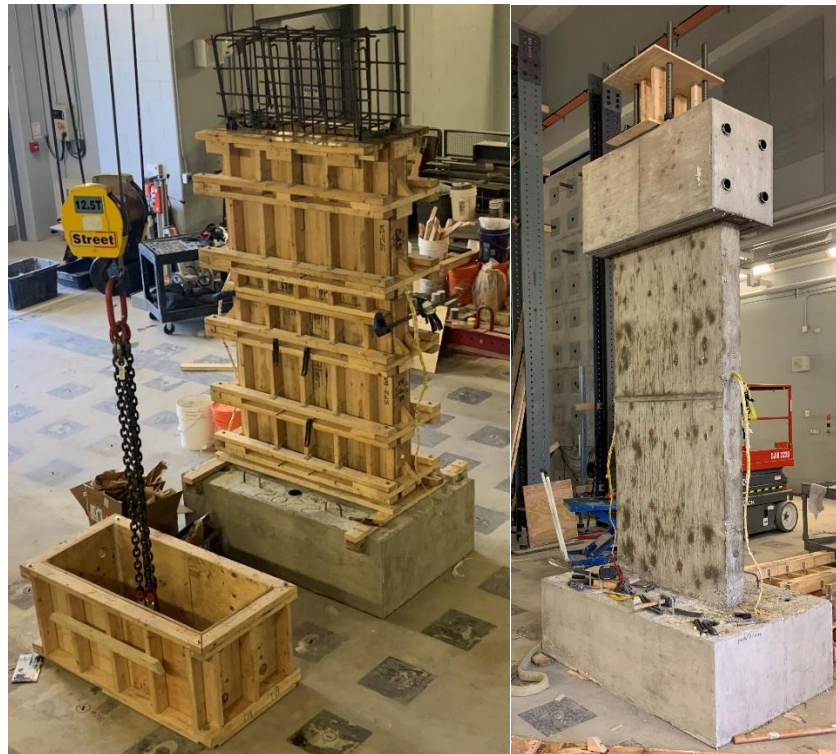
*Figure 3.9: Wall and Cap Beam Formwork before (left) and after (right) Casting*

piece of plywood was cut to the width of the cap beam, with holes cut out of it for the cast-in-place threaded rods. After the concrete was poured, this extra piece of plywood was fastened into place and 4 threaded rods were driven into the wet concrete. These rods were used to secure the actuator which would impose the axial load on the wall. Figure 3.9 illustrates the wall before and after casting.

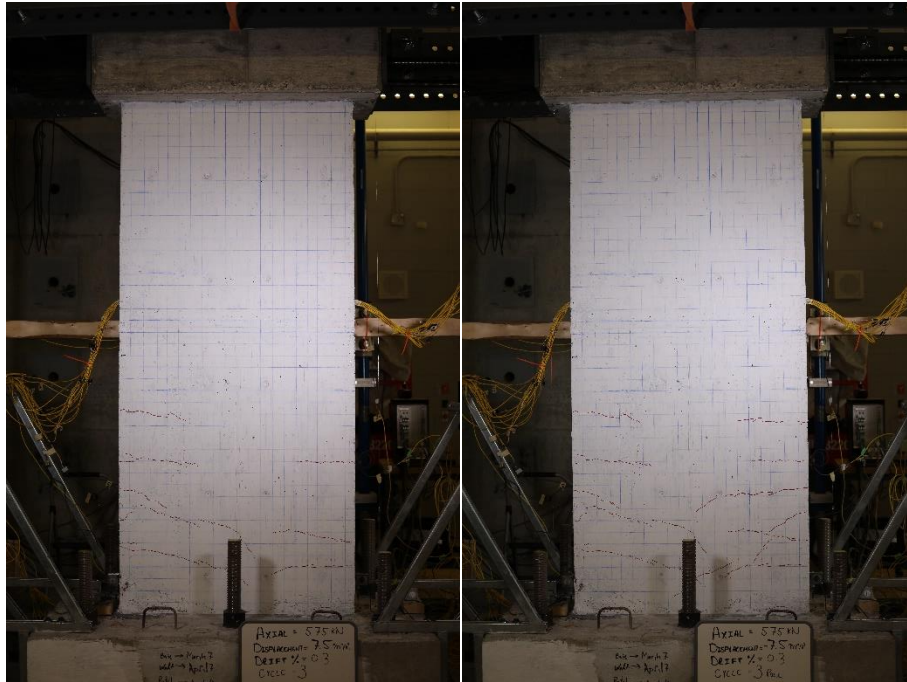
*Figure 4.7: Wall at 0.3% Drift (Push on the Left, Pull on the Right)*

The cracks were able to close during unloading until after the displacement cycles of 25mm (1.0% drift). During the fourth displacement of 7.5mm (0.30% drift), more flexural cracks appeared on the tension faces of both the push and pull cycles (refer to Figure 4.7). These cracks appeared at a maximum height of 850mm above the base and the lower cracks became diagonal in the web section of the wall. These were identified as shear cracks. The flexure-shear cracks only occurred in one crack on either side of the wall at a height of 300mm above the base. Some spalling surfaced at the toe of the wall in the SCC surface repair region on the push side. The fifth displacement of 10mm (0.4% drift) saw the development of flexure-shear cracking up to a height of 850mm above the base of the wall (refer to Figure 4.8). Cracks were observed and measured at heights of half of the height of the wall. Yielding was expected to occur during the fifth displacement cycle. This cycle saw the largest increase in crack lengthening. During the sixth displacement of 12.5mm (0.5% drift), more cracks appeared on the tension face of the pull cycles, however no new cracks formed on the tension face of the push cycles (see Figure 4.9). The existing cracks continued to widen and lengthen diagonally through the web. Spalling continued to develop at the toe of the wall in the SCC repair region on the push side.

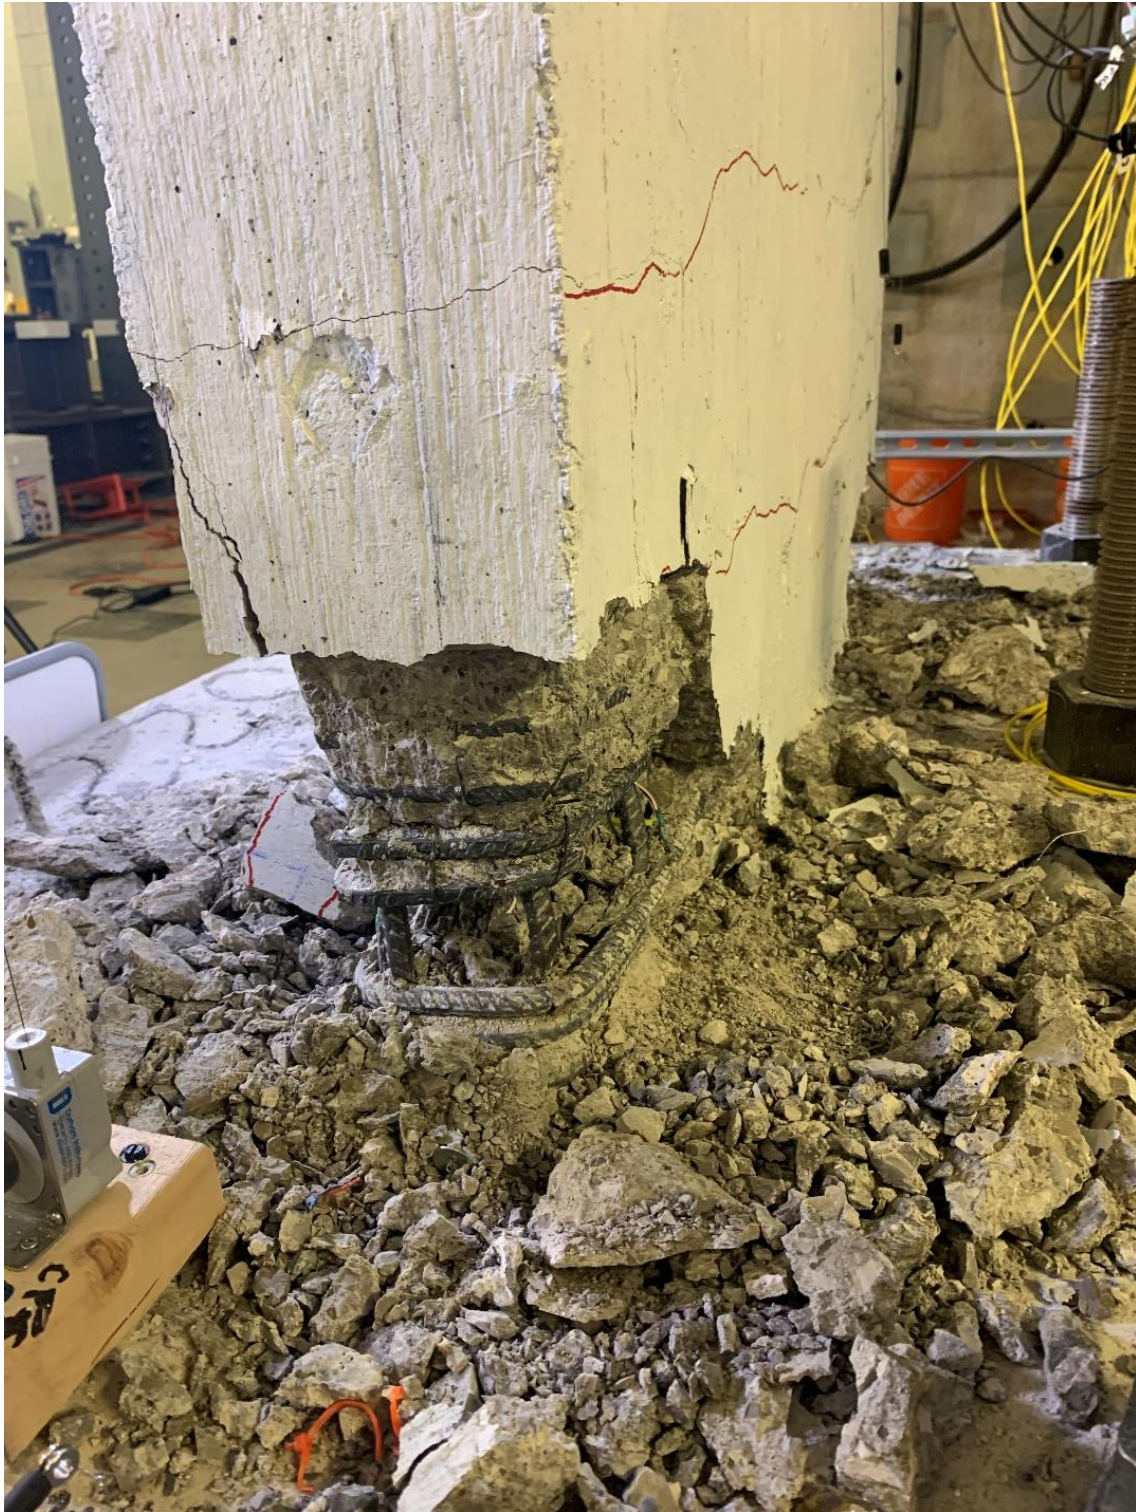
*Figure 8.122: Spalling and Crushing of Concrete at Toe, Non-Actuator Side*
