# **Heritage Considerations in Fire Safety Engineering**

A thesis submitted to the Faculty of Graduate Studies in partial fulfillment of the degree requirements for the degree of Master of Applied Science

Graduate Program in Civil Engineering  
York University  
Toronto, Ontario  
August 2021

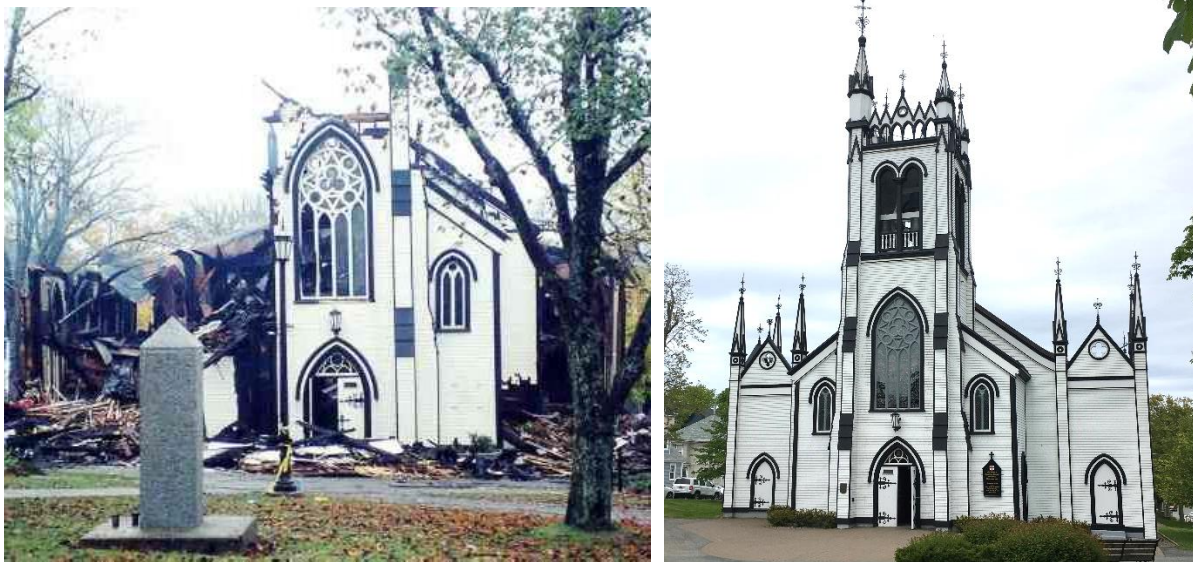
*Figure 1.1. St. John's Anglican Church in 2001 after the fire ((St. John's Anglican Church, Lunenburg, before and after November 1, 2001, 2001)) and the rebuilt church as seen in 2017.*

The desire to rebuild after fire also applies to heritage buildings without world renown, such as the St. John's Anglican Church in Lunenburg, Nova Scotia, which was rebuilt after a fire resulting the loss of over 50% of its heritage fabric in 2001 as seen in Figure 1.1 (Canada's Historic Places, 2006).

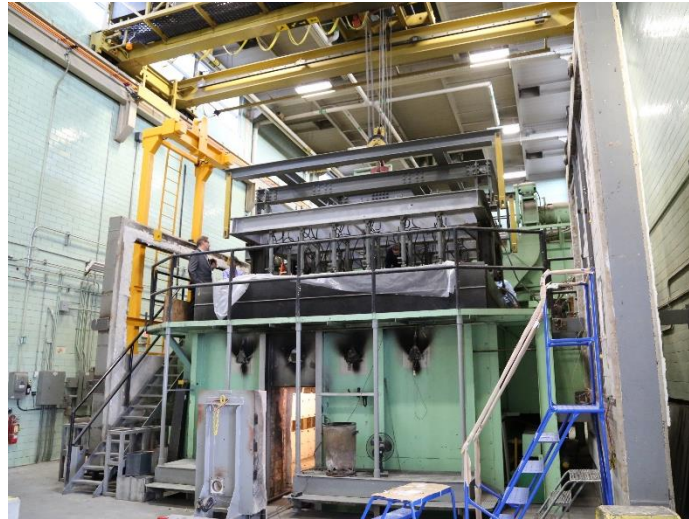
*Figure 2.3. A standard fire furnace of fixed dimensions (photo by John Gales used with permission).*

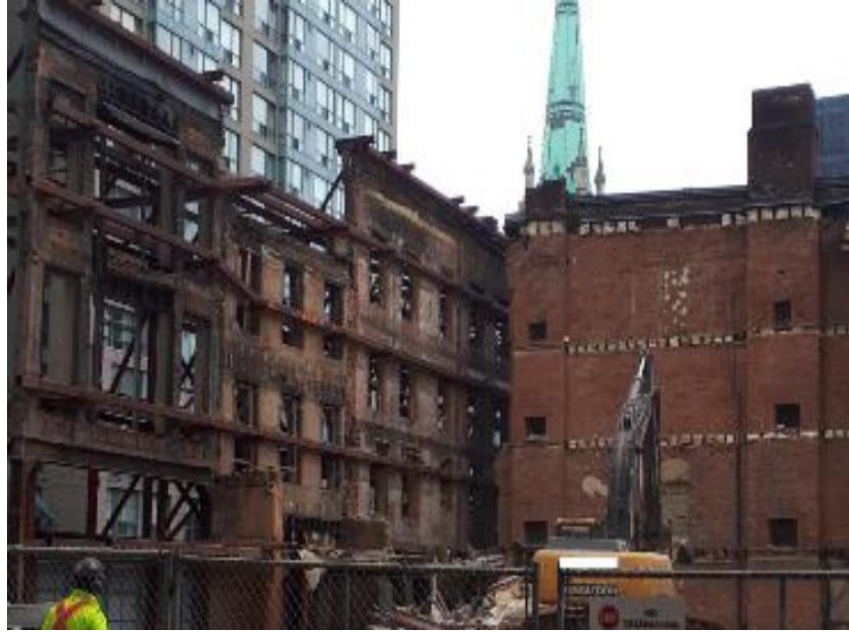
*Figure 2.5. Historic facades as seen in 2019. Removed buildings are fifth, sixth, and seventh from bottom right in historic photo (Figure 2.4) (photo by John Gales used with permission).*

The historic facades (seen in Figure 2.4 and 2.5) being incorporated into the new 65 King Street high rise are part of the St. Lawrence Neighbourhood Heritage Conservation District, designated in 2015 and currently under appeal to the Local Planning Appeal Tribunal (LPAT). In Toronto, the Heritage Conservation Districts are protected under Part V of the Ontario Heritage Act. The addresses of the buildings partially demolished were 71-85 King Street East, and they were all also listed under Part IV, yet they were deconstructed in 2019 for the new high rise due to a Heritage Easement Agreement. These agreements are reached to preserve some elements of the building, in this case only the façade, and to control the demolition of these protected buildings. Within the heritage conservation field keeping only the façade of a building, known as facadism, is a controversial practice that was popular between the 1970s-90s but is now seen to compromise the authenticity of the heritage site (Cheung Chin Yan, 2015). Alternately to facadism, interventions or adaptive reuse to facilitate the continued use of the building is preferred. The building's functionality holds heritage value (along with interior elements), and is more valuable than just the façade (Kyriazi, 2019).

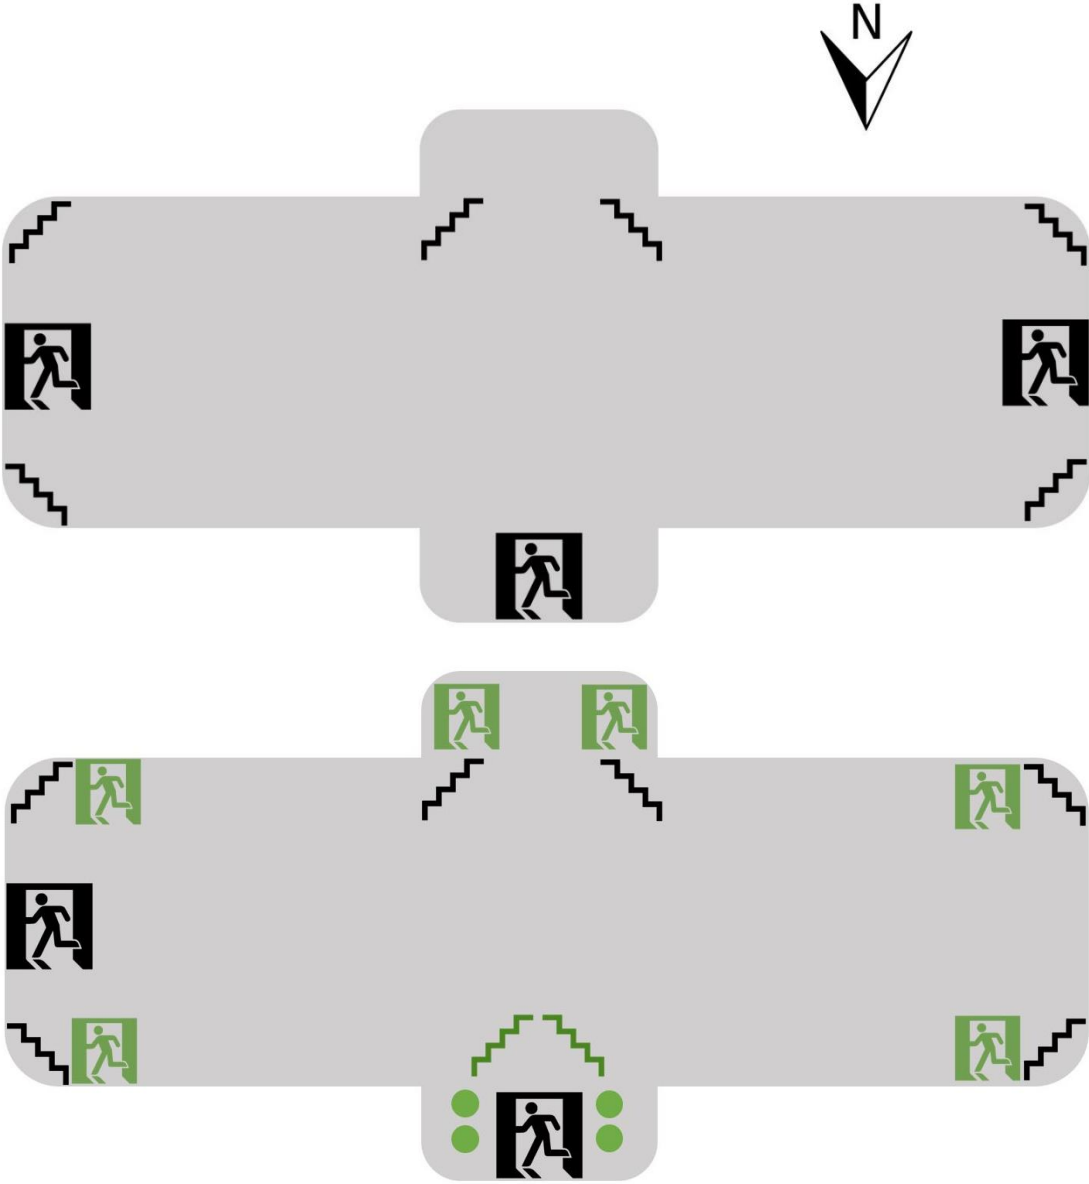
Figure 3.1. Simplified museum floorplan showing the historic exit and stair locations in black (top), and current layout with additional elements (stairs, exits, and columns) in green (bottom). Three new exits in back corners simplified to one exit on each side in diagram (seen at the top of the diagram).

All these interventions were implemented, illustrated in Figure 3.1, in an effort to improve the fire safety and emergency evacuation of the building and to comply with modern building codes. The ultimate goal of code compliance is to improve life safety in the building in the event of fire or other emergency egress situation, but code compliance doesn't necessarily equate with improved fire safety.

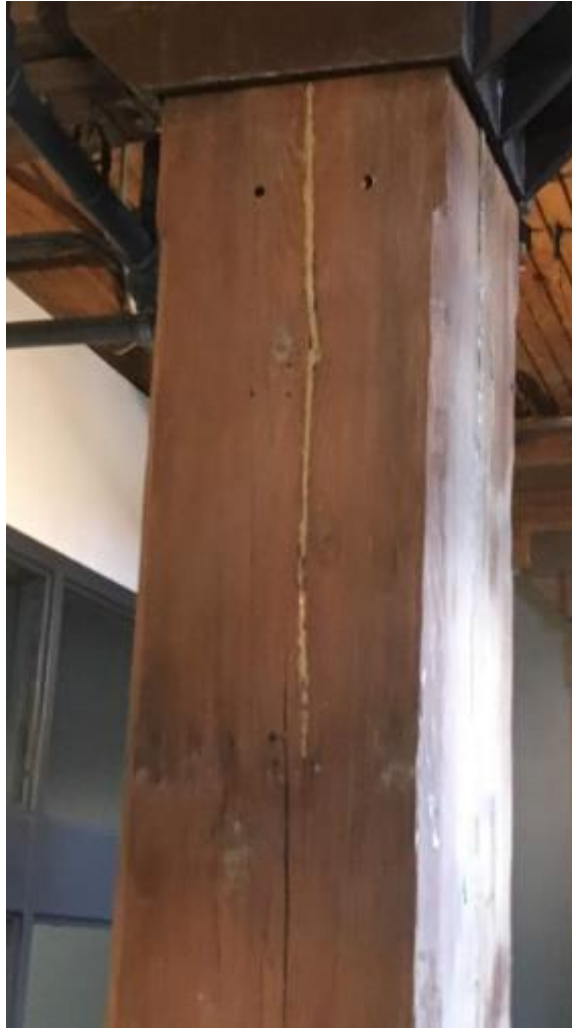
*Figure 4.1. Partial attempted sealant repair on a radial crack present on a column.*

This lack of guidance coupled with conservation guidelines that value minimal interventions leads to practices that are unproven. For example, a key factor that affects the fire performance of all timbers is the presence of radial cracks or gaps within the timber (Stanke, Klement and Rudolphi, 1973; *Technical Report No. 10: Calculating the Fire Resistance of Wood Members and Assemblies*, 2018). Radial cracking from shrinkage (checking) occurs with significant reductions in the moisture content of timber. These cracks can penetrate deep within the cross-section of the timber member. Significant changes in moisture content usually occur when there are changes in use or occupancy of the building, or during renovations when the building is not conditioned as usual. There is little information currently available regarding how these radial cracks within timber will affect a timber structural element's fire performance. Often one fills the crack in-situ to negate any potential reductions in fire resistance, as seen in Figure 4.1. Products known as wood filler and wood putty are readily available and advertise the ability to repair cracks and surface defects on wood. These attempted repair practices have insufficient evidence to support their use for fire performance purposes and can unduly compromise the architectural appearance of a timber structure.

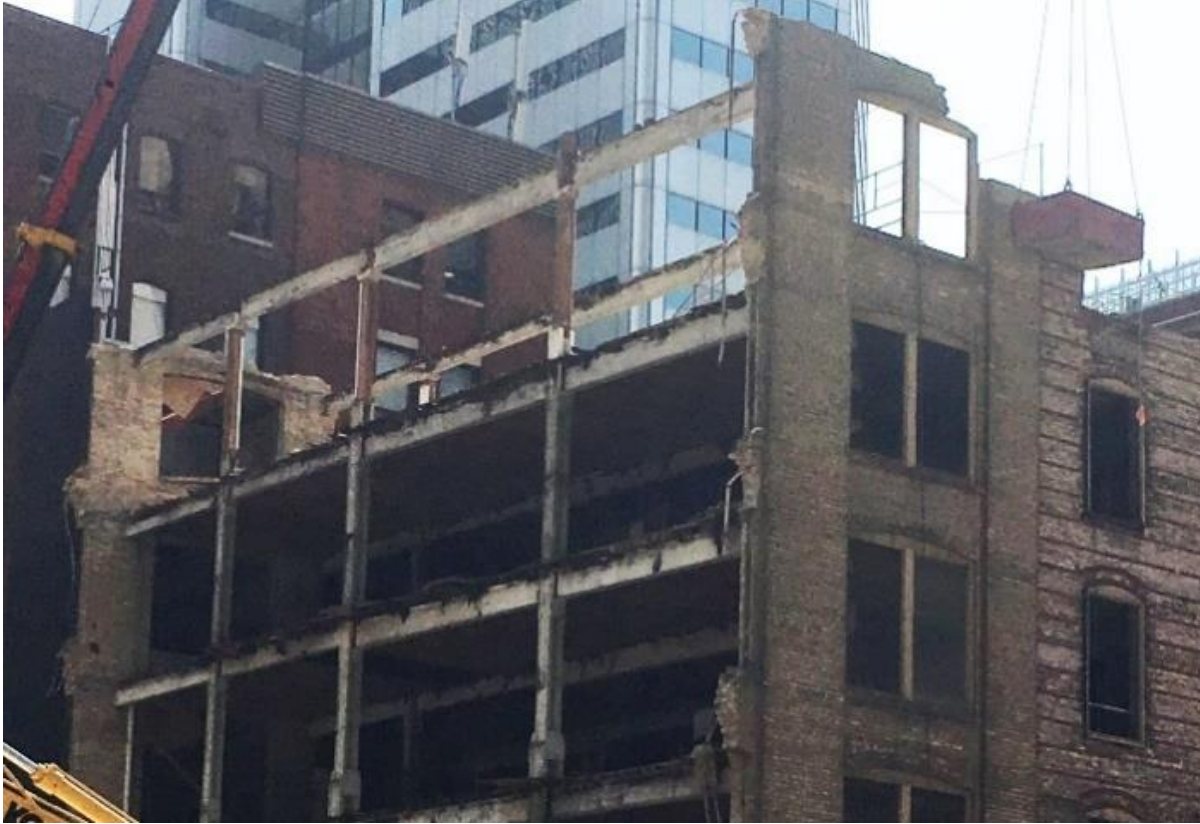
*Figure 4.2. Material acquisition from an industrial building in Toronto, Canada.*

The timber material was collected from a former industrial building in Toronto, Canada, built in 1905. The material acquisition occurred during the partial deconstruction of the building to accommodate a new high rise on the site that will incorporate a small portion of the original façade. The building was a 6-storey brick masonry structure with interior elements made of timber and steel, the timber elements tested herein were found on the upper (5th and 6th) floors as seen in Figure 4.2. Its original use was industrial but had been converted to commercial office space for contemporary use. The timber members were encapsulated at the time of deconstruction, as observed by the authors, which is common with heritage timbers. The first National Building Code in Canada, published in 1941, limited combustible construction to 4 storeys which terminated the construction of high rise timber structures (Koo, 2013). For the 6-storey building, it can be assumed that the timber on the upper levels was encapsulated sometime after 1941 to comply with building codes of the time, hypothesized by the authors after the change from industrial to commercial use.

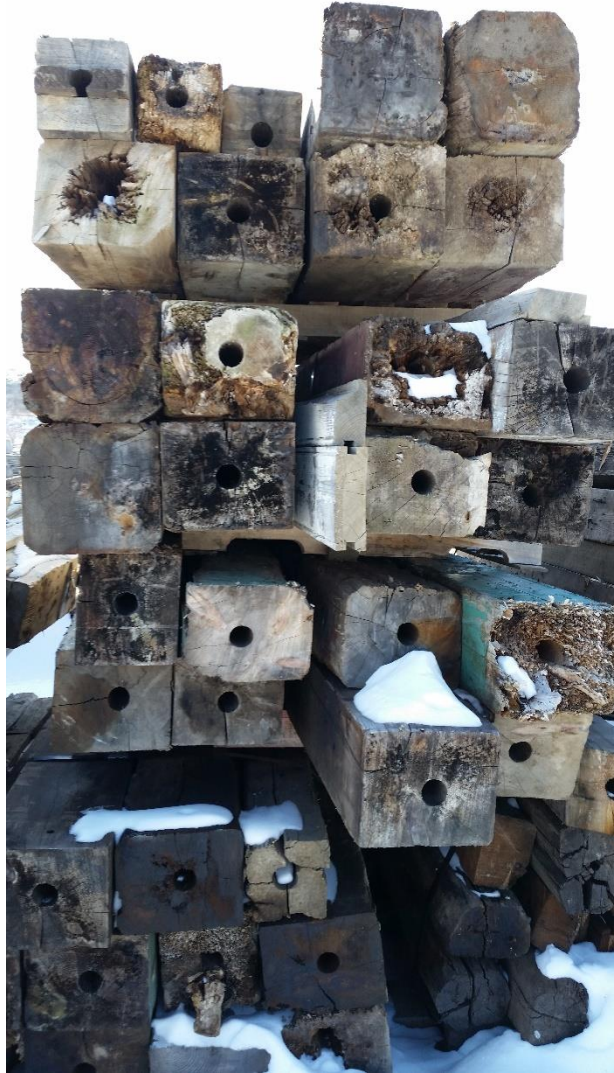
*Figure 4.3. Improper storage of heritage timber materials.*

Collecting viable heritage materials for destructive testing presents unique challenges concerning limited access to materials and their conditions. The larger timber members used in high rise construction (between 5-8 storeys) can only be found in buildings built before 1941 in Canada, which contributes to their rarity. Additionally, they are often found in designated heritage buildings that are protected from removal or demolition. The heritage materials must also be in serviceable condition, so any materials from buildings being demolished due to deterioration are not representative of heritage timbers in use, and therefore cannot be used. Members that have been stored outside during renovation or deconstruction projects can also be subjected to damage from moisture and/or pests and become structurally compromised after removal. Figure 4.3 shows unsuitable storage of materials of a different site found in Canada where the authors rejected other samples. These considerations exemplify the difficult to study nature of procuring in-situ testing of older material specimens and the need to provide guidance on material collection for other practitioners.

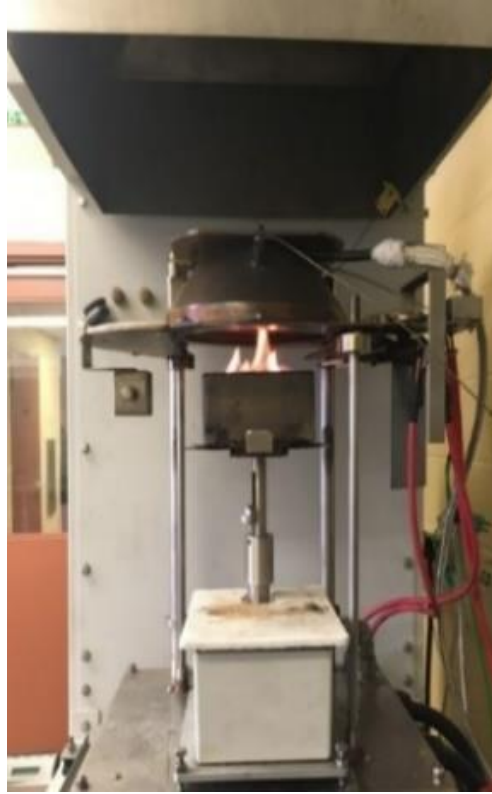
*Figure 4.7. Cone calorimeter test setup.*

Following heat exposure in the Cone Calorimeter apparatus, each of the eight samples was cut in half, perpendicular to the direction of the crack. Char depth was then determined by measuring the depth of undamaged timber, determined visually by colour as the region that had not turned black or brown, and subtracting the undamaged depth from the initial depth of the sample. Char depth was measured at quarter and mid spans of the samples.

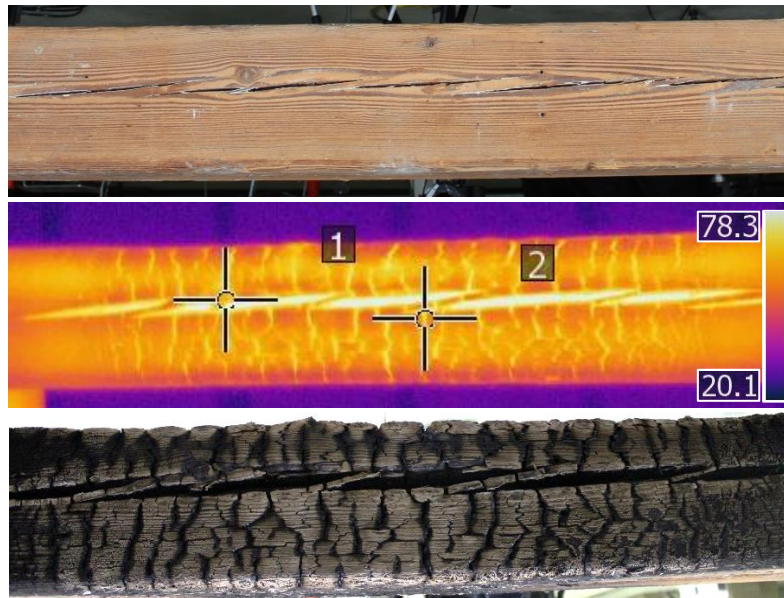
*Figure 4.8. Side A crack progression before (top) and after fire (middle and bottom) on Heritage 2 (identifiable markings were recorded temperature markers and scale is in °C).*

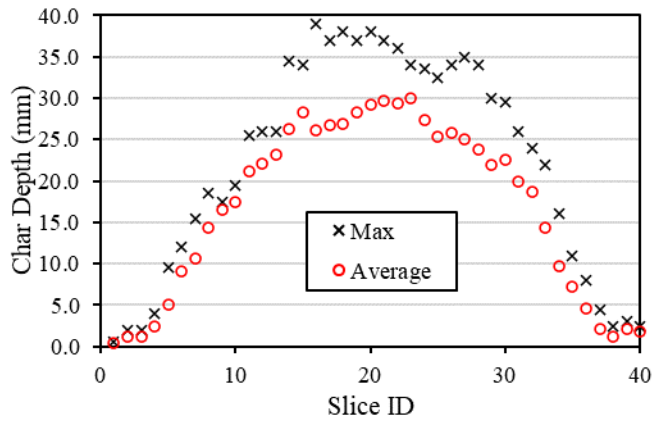
Figure 4.10. Char depths after loading on the sides of Heritage 2, where Max is the maximum char depth around the crack, and Average is average char depth away from the crack.

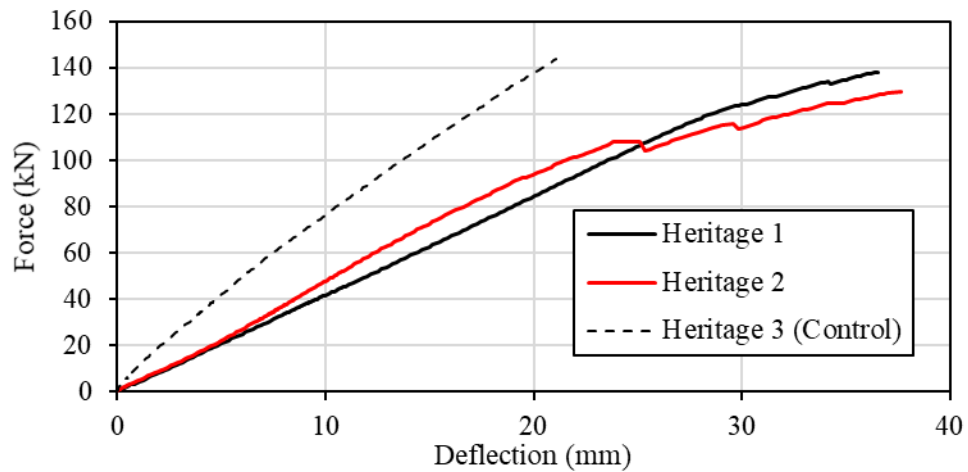
Figure 4.13. Force vs deflection for the charred heritage and control members.

The deflections computed during the loading tests for the two heated members, Heritage 1 and 2, and the control member, Heritage 3, are presented in Figure 13. The deflections measured in millimeters are plotted in relation to the force applied in kilonewtons until failure.

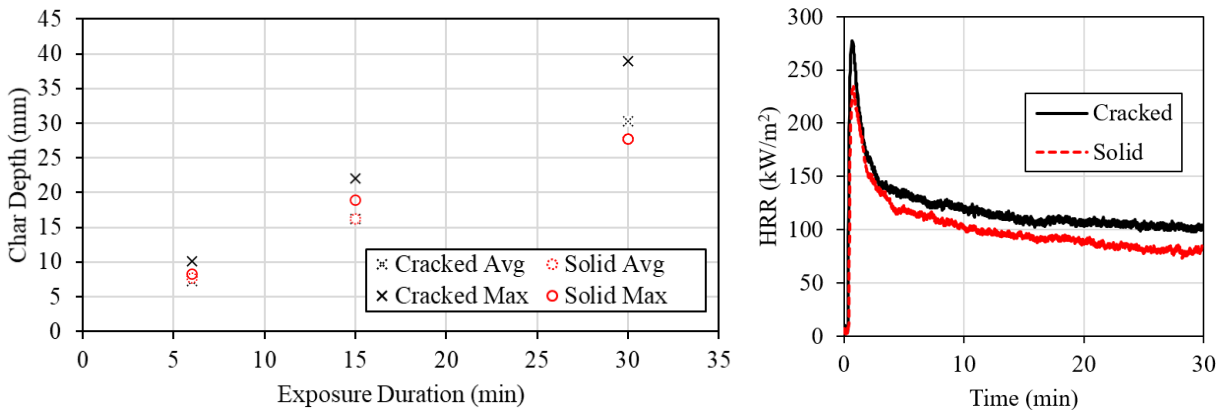
Figure 4.15. Average and maximum char depth of cracked and solid specimens, and heat release rates of cracked and solid samples tested to 30 minutes.

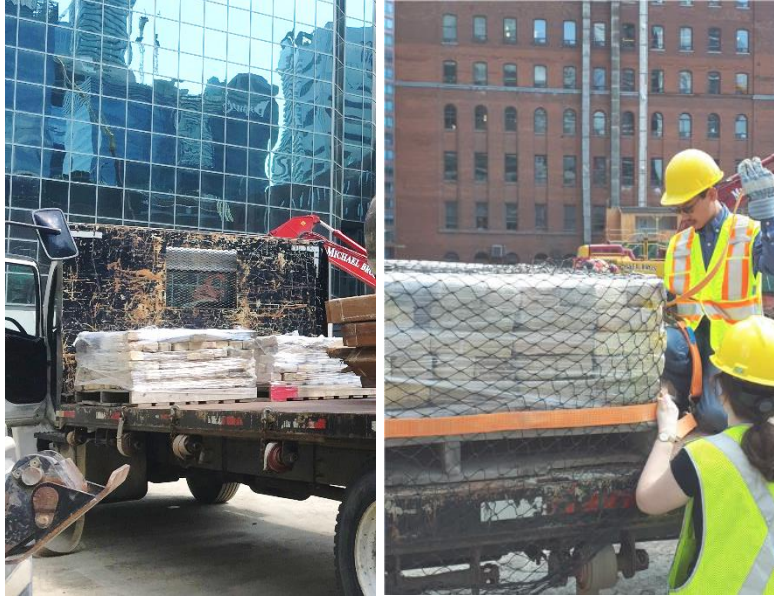
Figure 5.1. Material collection of 1900s bricks from deconstruction site.

Masonry materials were acquired from four different building time periods in Ontario: the 1840s, 1900s, 1920s, and today. The heritage materials (from the first three eras) were collected from building demolition sites, where the masonry's structural integrity was not the reason for the demolition. The samples from the 1900s were collected from the same former industrial building the timber materials were sourced from, and can be seen in Figure 5.1. The 1840s bricks were sourced from the brick and beam building on King Street East presented in Chapter 2 that was demolished due to a heritage easement agreement (as with the 1900s bricks as well). As can be seen in Figure 5.2, the 1920s bricks have the name PHIPPEN embossed in the frog of all the masonry units reclaimed from the 1920s era house. The company, Phippen, H.W., & Son were included in a list reported by the Government of Canada of firms that shipped bricks made from domestic clays in 1933 (Department of Trade and Commerce Dominion Bureau of Statistics, 1934). The same challenges regarding collecting and storing heritage materials discussed in the previous chapters also apply to the materials collection herein. The available stock of heritage clay brick materials is summarized in Table 5.1. and 8 bricks from each were tested in the provisional study presented.

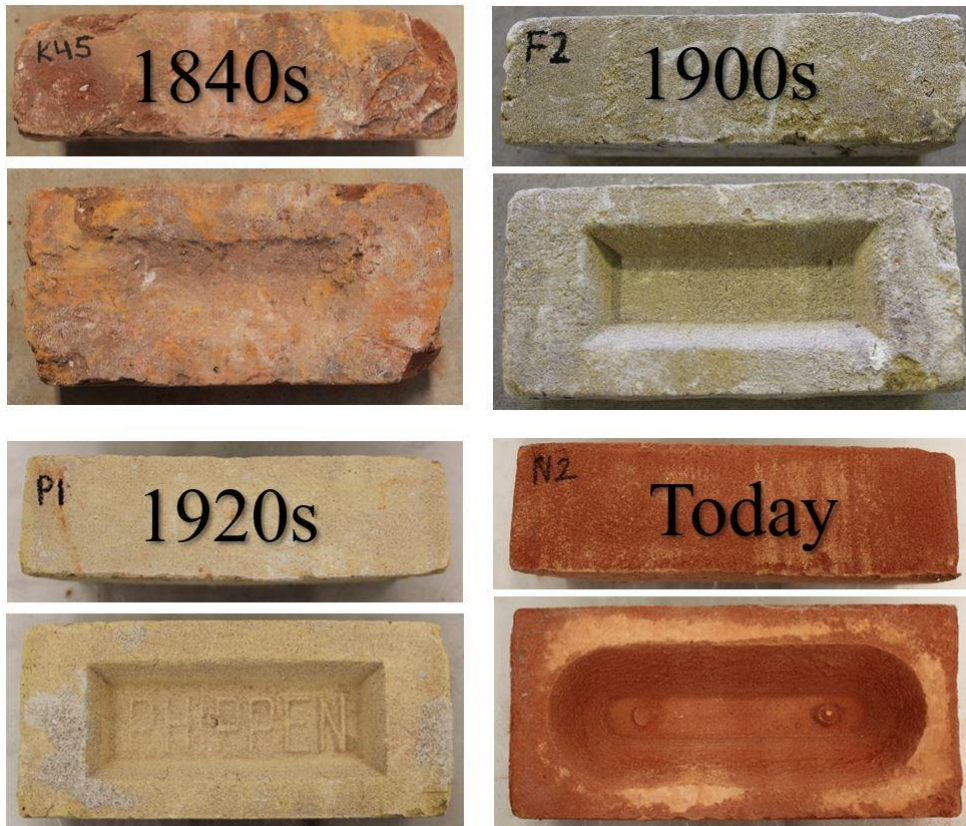
Figure 5.2. Brick samples from the 4 eras of Canadian brick masonry construction.

All the masonry tested are moulded clay bricks with a frog, as can be seen in Figure 5.2. The densities of the bricks tested range from 1505-1905 kg/m<sup>3</sup> with an average of 1656 kg/m<sup>3</sup>, and the manufacturer specified density of the new bricks is 1650 kg/m<sup>3</sup>. These are all within the expected density range of 1300-2250 kg/m<sup>3</sup> for solid clay brick (Drysdale and Hamid, 2005). The modern clay units are handmade using historic techniques and are predominantly used as replacement heritage bricks when needed.

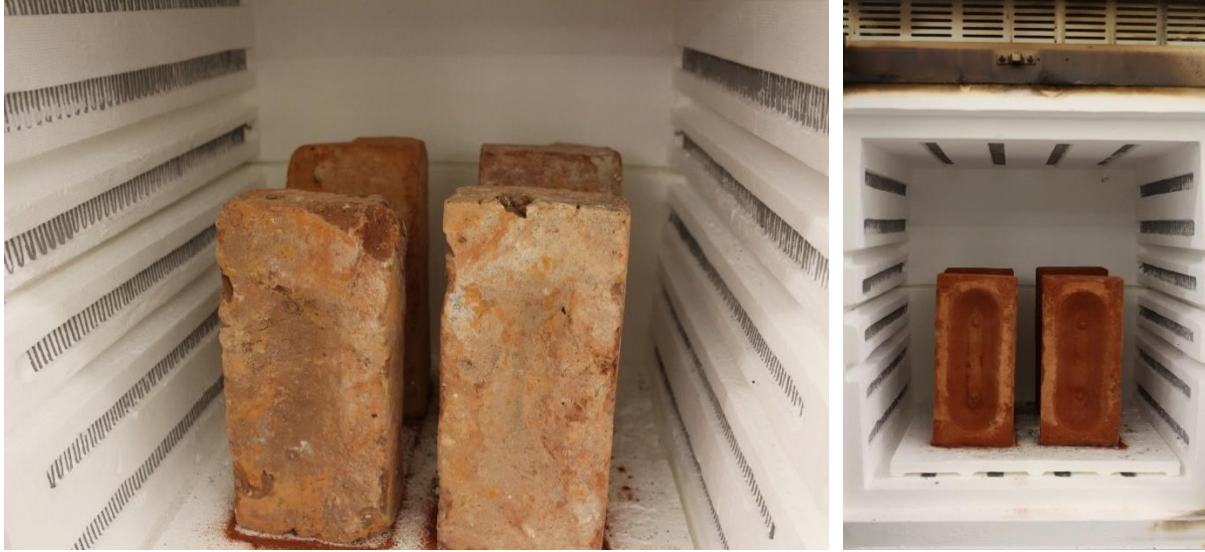
*Figure 5.3. Brick configuration in the furnace (1840s and new (2010s) bricks).*

Trials to determine the true temperature inside the furnace, using thermocouples and comparing to the display in the furnace. It was determined that the furnace is on average 16°C hotter than the displayed temperature, so the target temperature was adjusted to get the desired internal temperature in the furnace. This value of 16°C is the average temperature difference between the furnace display and our thermal couple, of 19 values taken over a 5°C/min ramp to 500°C. A thermocouple was also placed in between the bricks to ensure a uniform heating with the brick configuration inside the furnace (configuration seen in Figure 5.3).

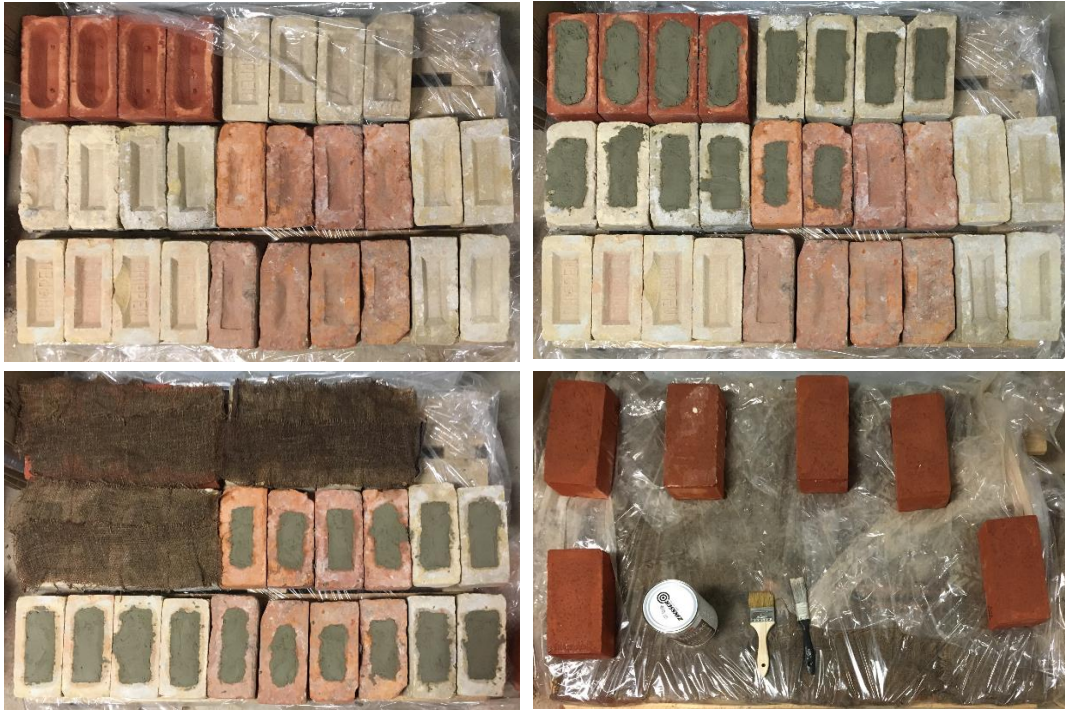
*Figure 5.4. Process of filling frogs with mortar, covering with wet burlap and wrapping in plastic to moist cure for 48 hours.*

The sample frogs were then filled with a high early strength cement mortar (Portland Type HE) with a water, cement, and sand mix ratio of 0.5:1:2 , as per CSA A82-14 (Standards Council of Canada, 2015), and allowed to cure for at least 48 hours before shellac and capping. The compression faces were then coated with shellac and dried for 24 hours, to seal any pores in the masonry from absorbing any moisture during the plaster application. The compression surfaces were then capped with Plaster of Paris (No. 1 Moulding Plaster) with a water and plaster ratio of 29-32:45 grams, as per CSA A82-14. The capped surfaces were aged at least 24 hours before compression testing.

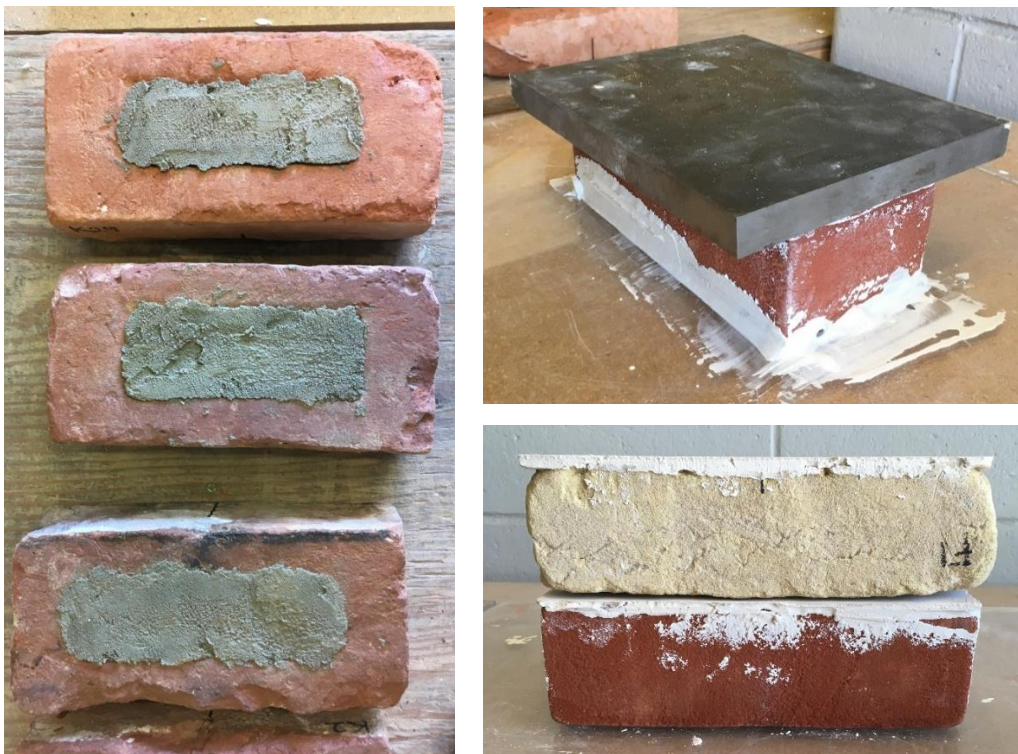
*Figure 5.5. Mortar filling and plaster capping of clay brick samples.*

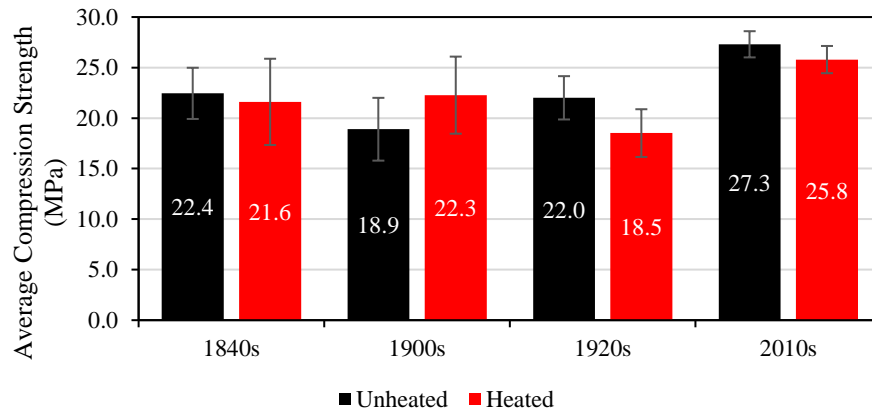
Figure 5.7. Average compression strength of heated and unheated heritage and modern bricks.

strength (MPa) of the 32 bricks tested and their standard deviations are presented in Figure 5.7 below. The samples are organized by time period, from oldest to newest, and separated into unheated and heated categories.

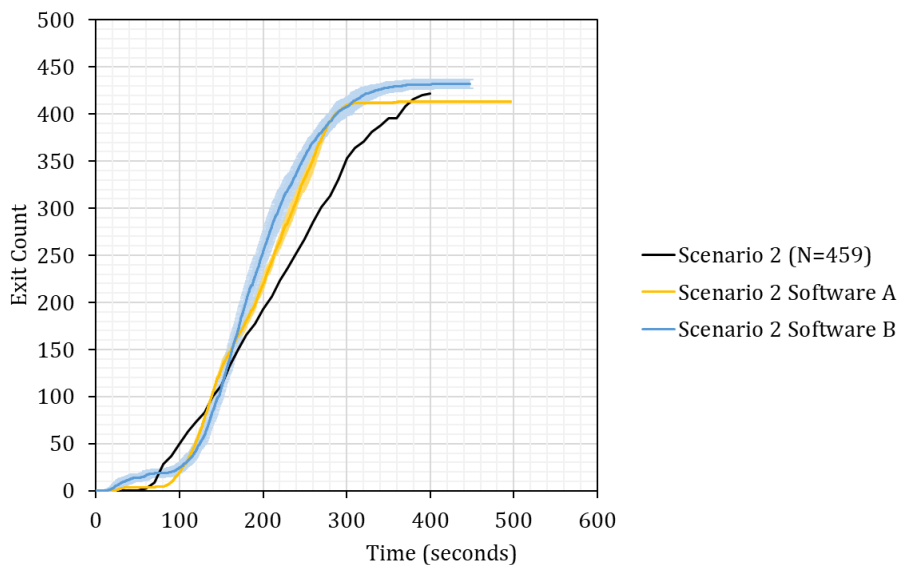
*Figure A4: Comparison between the model results and real data for Scenario 2 main entrance usage.*
