BEHAVIOR OF ENGINEERED CEMENTITIOUS COMPOSITE-  
REPAIRED SUPERELASTIC-SHAPE MEMORY ALLOY  
REINFORCED SHEAR WALLS

A THESIS SUBMITTED TO  
THE FACULTY OF GRADUATE STUDIES  
IN PARTIAL FULFILLMENT OF THE REQUIREMENTS  
FOR THE DEGREE OF  
MASTER OF APPLIED SCIENCE

GRADUATE PROGRAM IN CIVIL ENGINEERING  
YORK UNIVERSITY  
TORONTO, ONTARIO

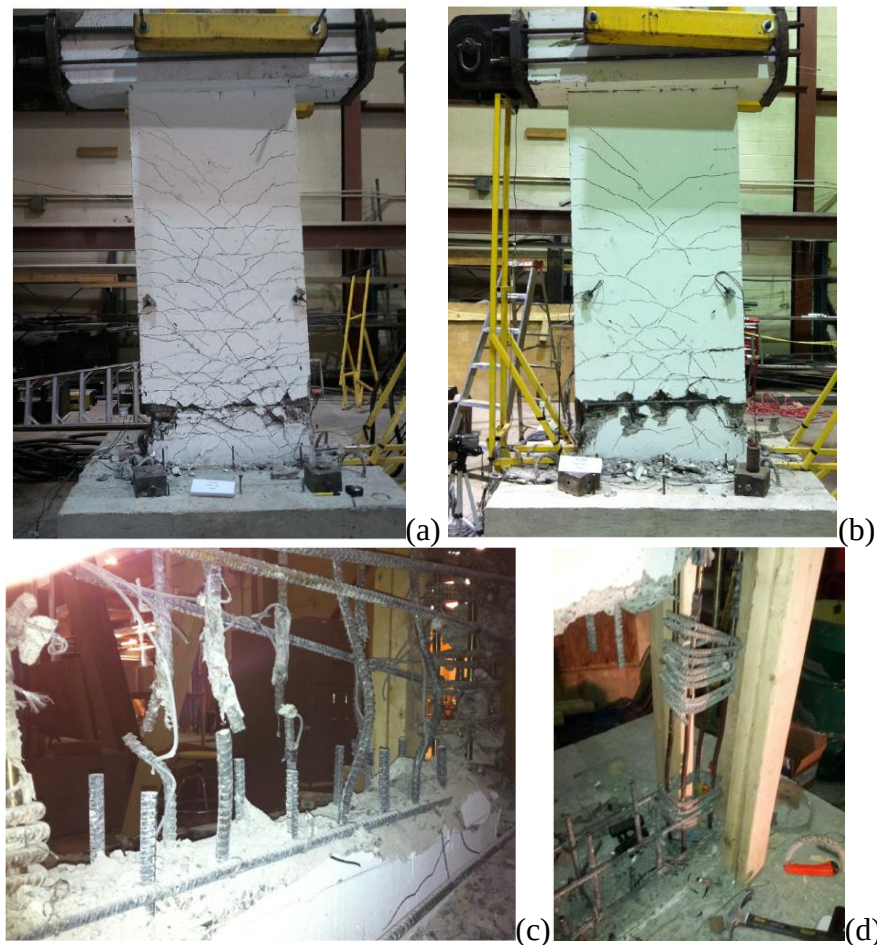
2.9 (a) and (b) show the conditions of the walls after testing. Both walls developed a wide crack spreading horizontally along the wall at the termination of the starter bars where the behavior of the walls was controlled. The walls failed due to the rupture of longitudinal reinforcing bars in the plastic hinge region, near the base of the wall. The steel reinforcement located in the boundary regions of W1-SR ruptured, whereas for W2-NR, the steel reinforcement in the web region ruptured. A subsequent research study repaired the damaged walls, where it was observed after concrete removal in the plastic hinge area that the SMA bars in the boundary zones experienced local buckling (Zaidi, Palermo and Dragmeriscu, 2016). It was reported that one SMA bar ruptured at the location of the mechanical couplers due to the sharp end screws. Figure 2.9 (c) and (d) illustrate the damage in the reinforcement of the SMA wall.

*Figure 2.9 Conditions of the walls at failure: (a) W1-SR; (b) W2-NR (Abdulridha and Palermo, 2013); (c) rupture and buckling of steel reinforcement in the web of W2-NR; and (d) buckling of SMA bars in the boundary zone for W2-NR (Zaidi, Palermo and Dragmeriscu, 2016)*

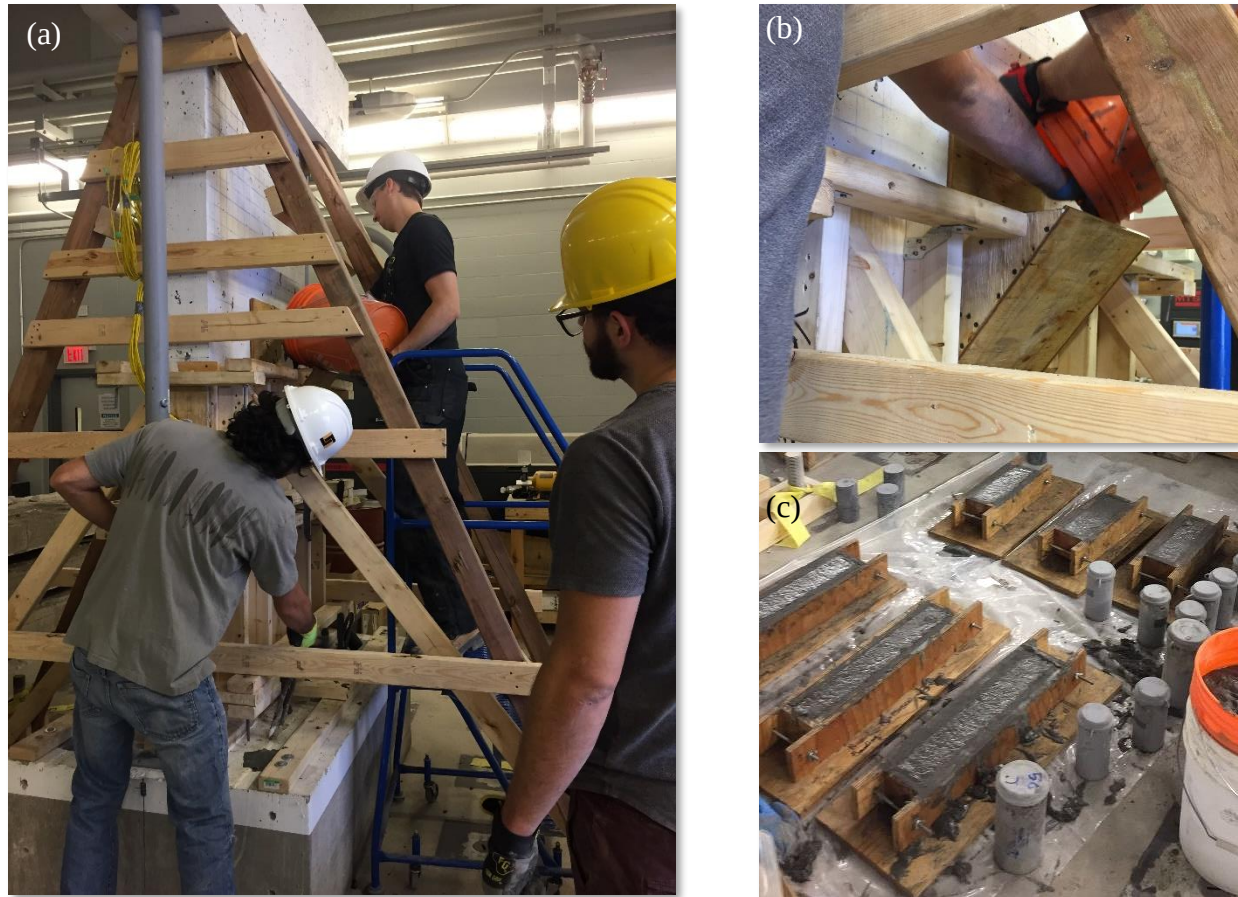
Figure 4.29 Procedure in Casting: (a) Casting of the wall; (b) pouring of ECC through the designed compartment; and (c) additional prisms and cylinders

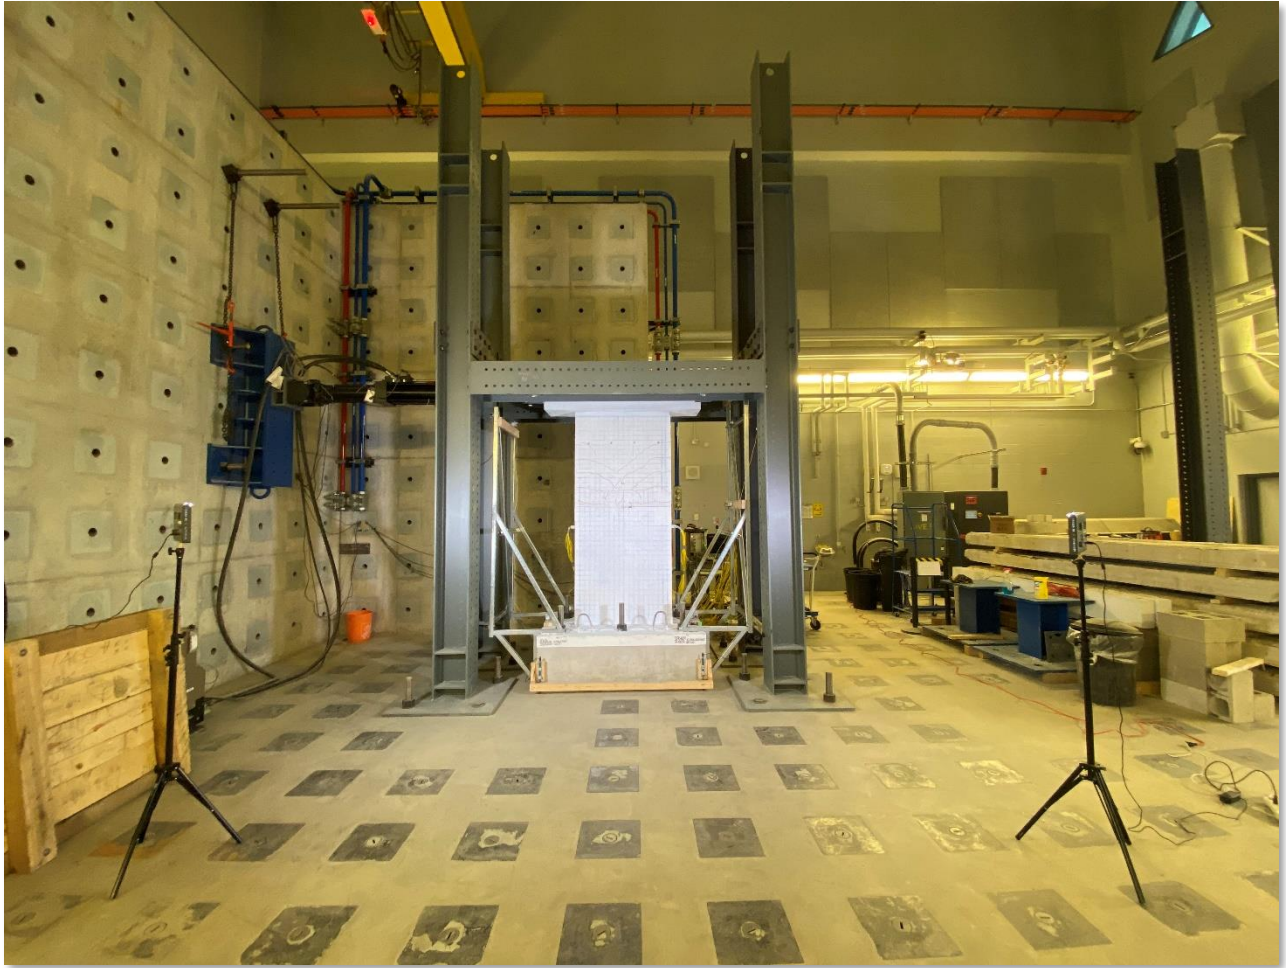
*Figure 4.35 Assembled experimental test setup*

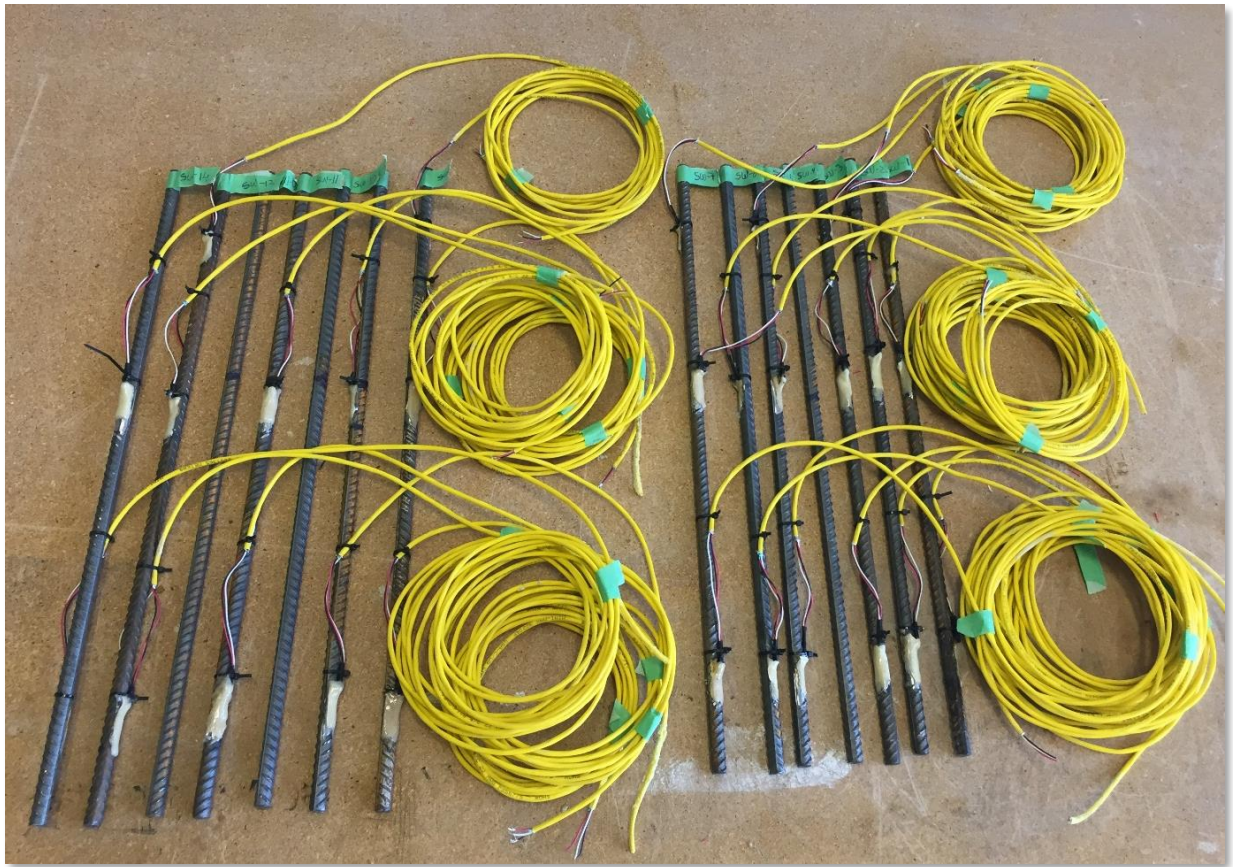
*Figure 4.37 Installation of strain gauges on new segments of steel bars*
