Back Analysis of Mount Polley Tailing Dam Failure

Md Abdullah Al Arafat

A thesis submitted to the faculty of graduate studies

ABSTRACT

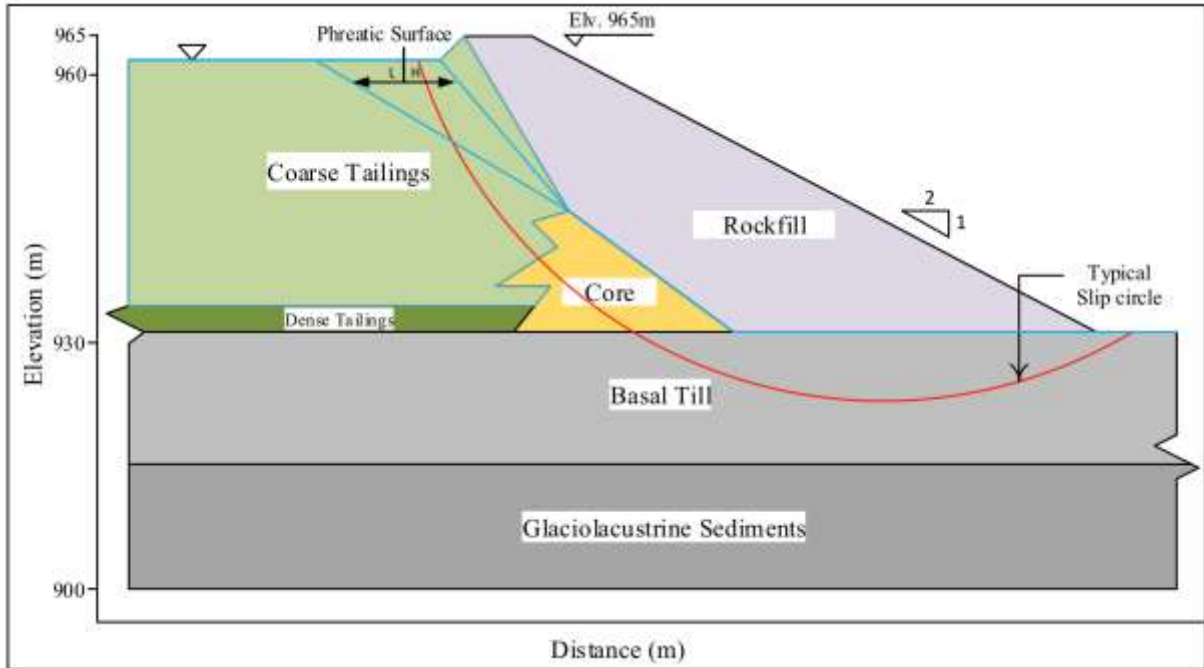
Figure 15: Preliminary design section reproduced from Knight Piesold Consultant (2005)

The first design report for the TSF was produced before the mining operation had started in 1997; however, it was revised in 2005. Stability analyses were performed for both static and dynamic conditions. Only the static part, however, was reproduced for this study as any seismic activity prior to the failure wasn’t recorded. A toe drain was added to all three dams: main, perimeter and south. The dams to be built in nine (9) stages had an ultimate elevation of 965 m. A schematic diagram of the dam is shown in Figure 15.

The material properties of the embankment materials are shown in Table 6. Most of the soil properties are described by using Mohr-Coulomb model. Tailings materials are additionally presented in terms of ‘Overburden function’ to assess the liquefaction effects. Hydraulic conductivities are also presented in the material properties tables; however, it was missing for Rockfill. A higher saturated hydraulic conductivity of 1E-05 m/s was assumed for the Rockfill in all the following analyses. However, hydraulic conductivities were only used in filter design; not in coupled stability analyses. Thin chimney drain, transition layer and clay liner were merged into Rockfill and Till layers respectively for the simplicity of the simulation.

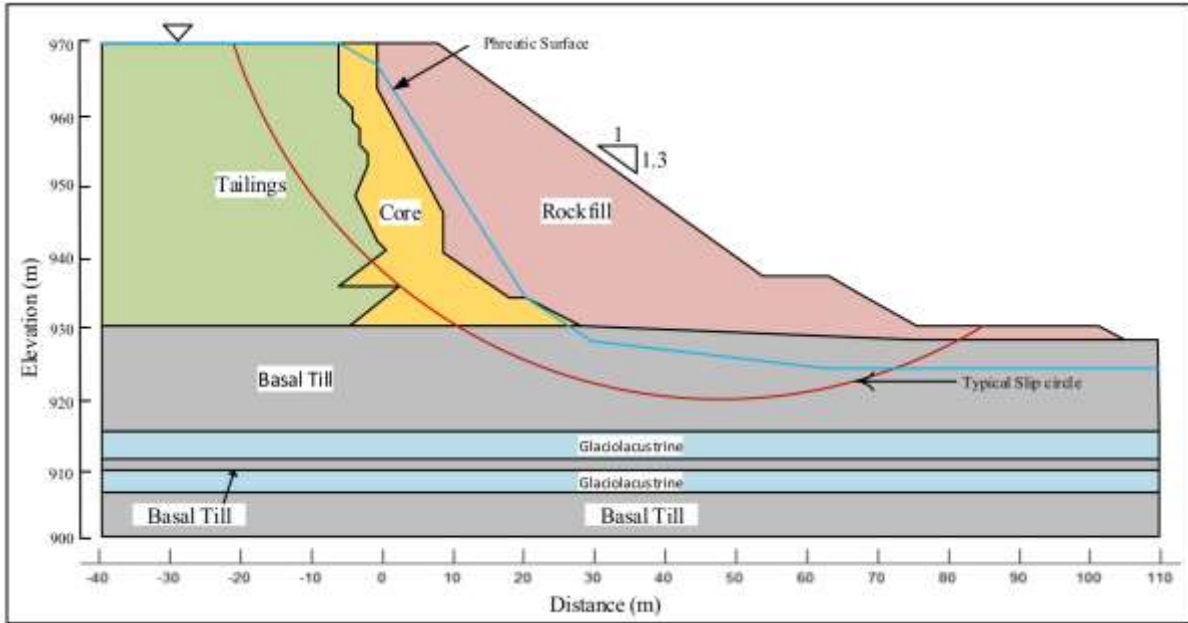
Figure 17: Geometry for the 9th stage dam design by AMEC (2012)

Over time, the design of the tailings dams changed significantly; however, the reason for the changes are unclear. The final height of the dam was modeled as 970 m which was greater than proposed 965 m in the original design. The downstream slope, however, changed from 2H:1V to 1.3H:1V. The cross sectional geometry also became irregular. The design foundation layers varied considerably from the previous analysis. A sandwiched till layer between two Glaciolustrine layers was used, possibly to simulate the irregularity of soil layers beneath the ground. The schematic diagram of the failed dam section is provided in Figure 17. The material parameters of the embankment soils were kept similar, with minor modifications, to that of Knight Piésold Consulting (2005). The angle of internal friction for GLU layer was reduced from 33° to 28° . The Rockfill was provided using an arbitrary shear-normal function described in Leps (1970) instead of Mohr-Coulomb function. Like the previous analysis, thin chimney drain and transition layers were merged into Rockfill. The clay liner wasn't used in the simulation.

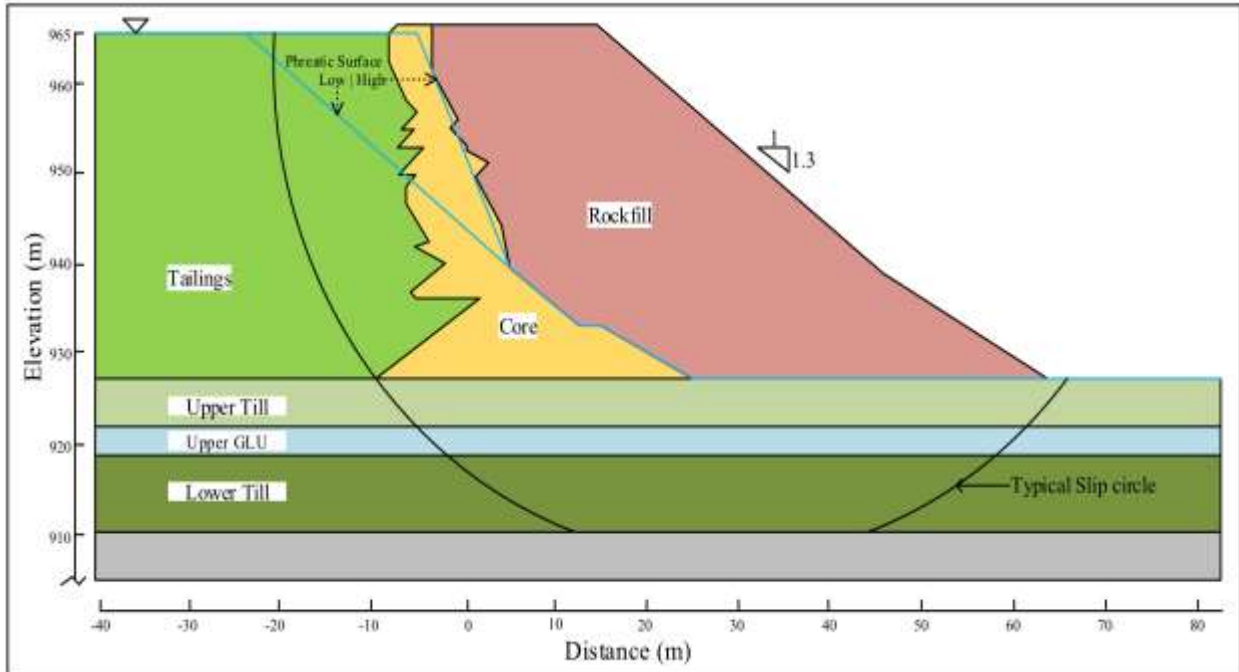
Figure 19: Cross sectional geometry used in analysis by Morgenstern et al. (2015)

Morgenstern *et al.* (2015) conducted a post failure analysis of the failed dam. The geometry of the failed dam section roughly replicated the geometry of the 9th stage design. The foundation conditions, however, differed significantly from the previous analyses. The design soil layers were determined based on two post-failure soil investigation reports conducted by Morgenstern *et al.* (2015) and ConeTec Investigations Ltd (2014). The choice of appropriate material models was also different. A newly introduced Upper Glaciolacustrine (GLU) layer was assigned in Overburden (SHANSEP) model to replicate the undrained condition. The geometry of the failed section is shown in Figure 19. The stability was analyzed incorporating Morgenstern-Price type of LEM in SLOPE/W. The material properties are shown in Table 10 which differed in mechanical properties from the previous analysis to some extents. Undrained shear strength ratio of 0.22 and 0.27 were used for GLU layers to understand the undrained response in overall dam stability. In a different simulation, this GLU layer was assigned using Mohr-Column model (similar to AMEC 2012, $C=0, \Phi = 30^\circ$) to test drained response of the dam. Lower till layer was found very stiff in the latest soil investigation; and so it was assigned as a weak bedrock. Due to unavailability of a defined shear-normal function in the report, the function used in Leps (1970) was used for the rockfill material.

Like the previous analyses, this set of analyses was performed without considering the field hydraulic boundary conditions. The locations of the phreatic surfaces were arbitrarily selected as ‘high’ and ‘low’. Thus, the effects of hydraulic conductivities of different layers of soil did not come into effects. The pore water pressure contour for higher phreatic surface is shown in Figure 20. Table 11 shows that the FOS of both undrained responses (Undrained shear strength ratio of 0.22 and 0.27) for GLU were close to 1. The drained response of the layer, however, shows much higher value of factor of safety. The sudden nature of the failure and these analyses results convinced Morgenstern *et al.* (2015) that the failure happened in an undrained manner in the ‘weak’ GLU layer.

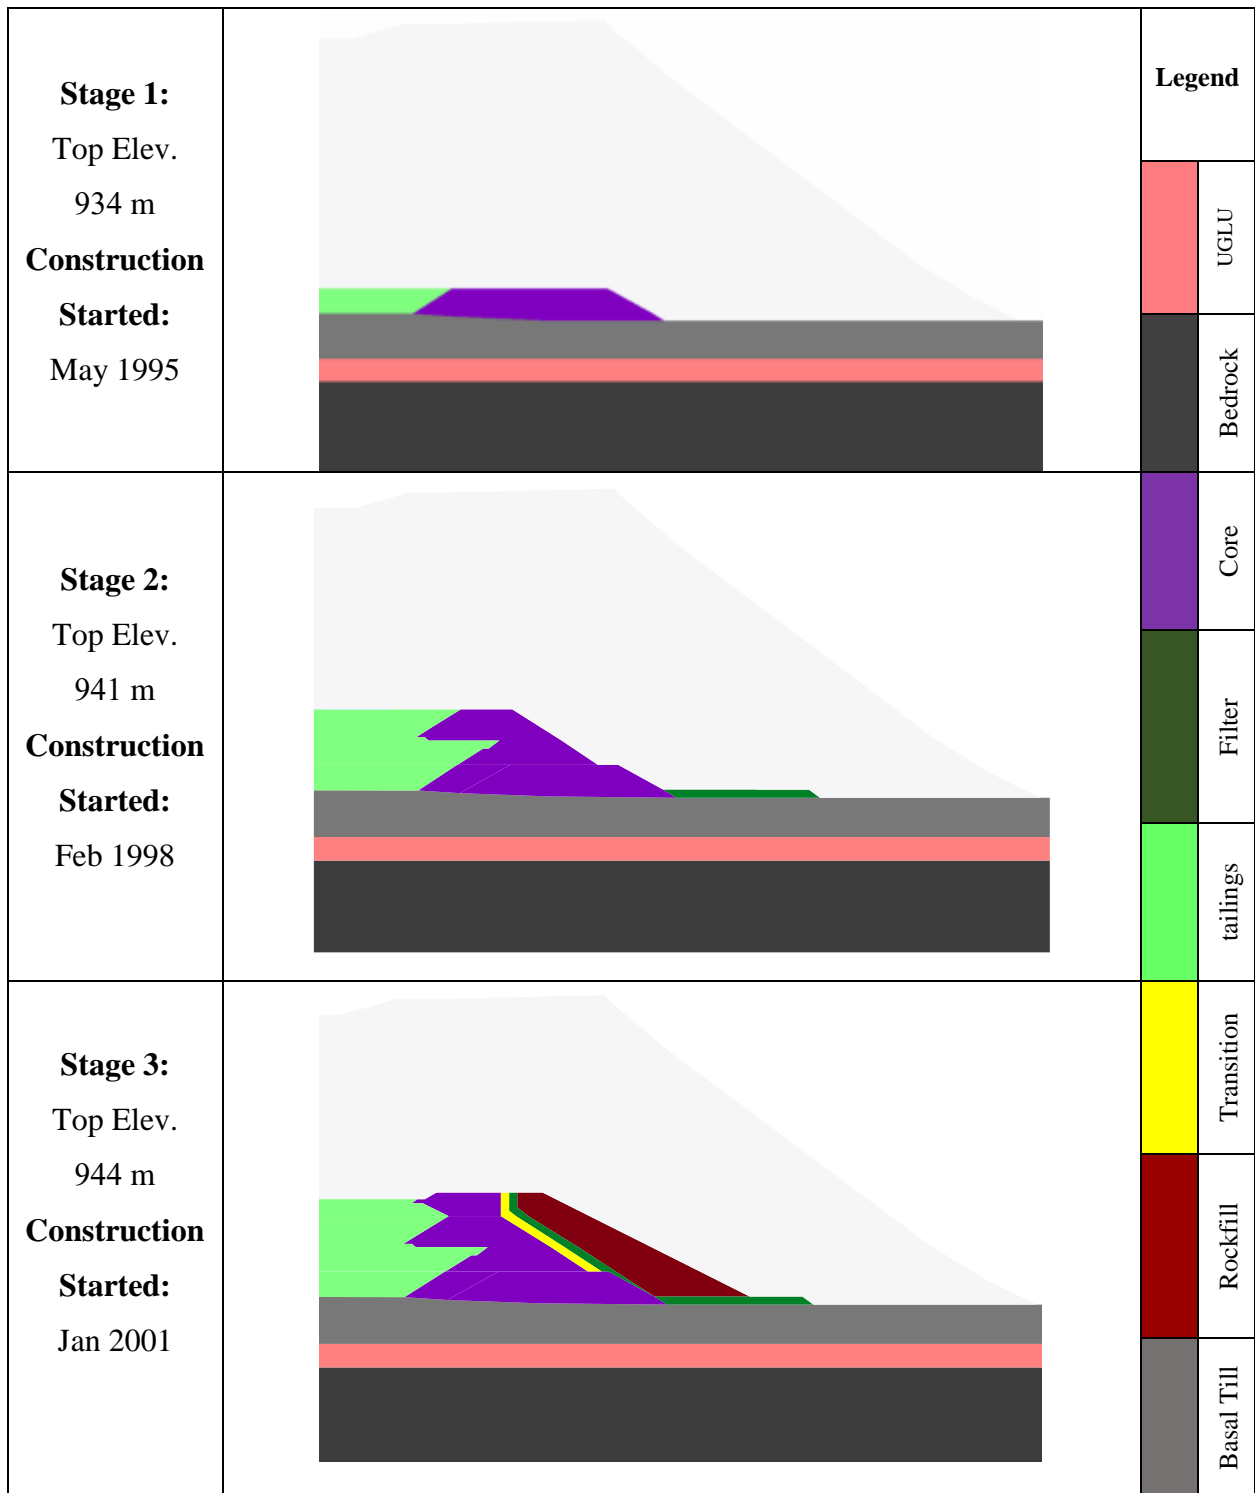
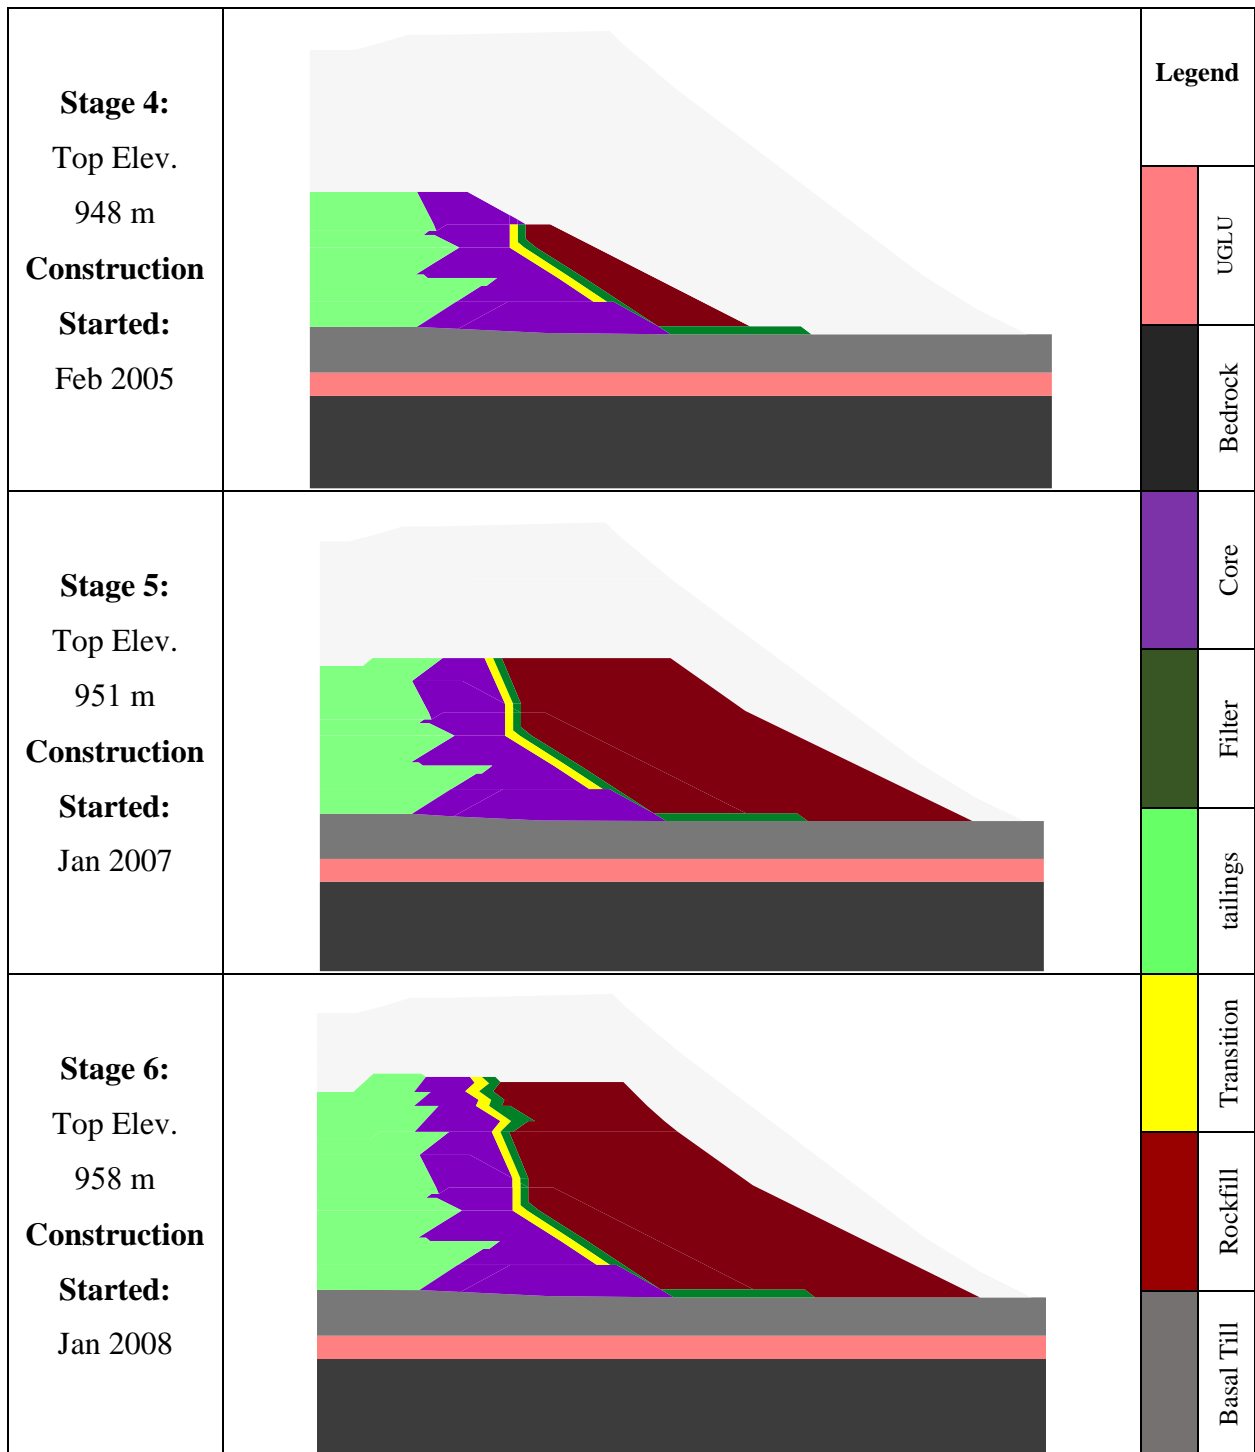
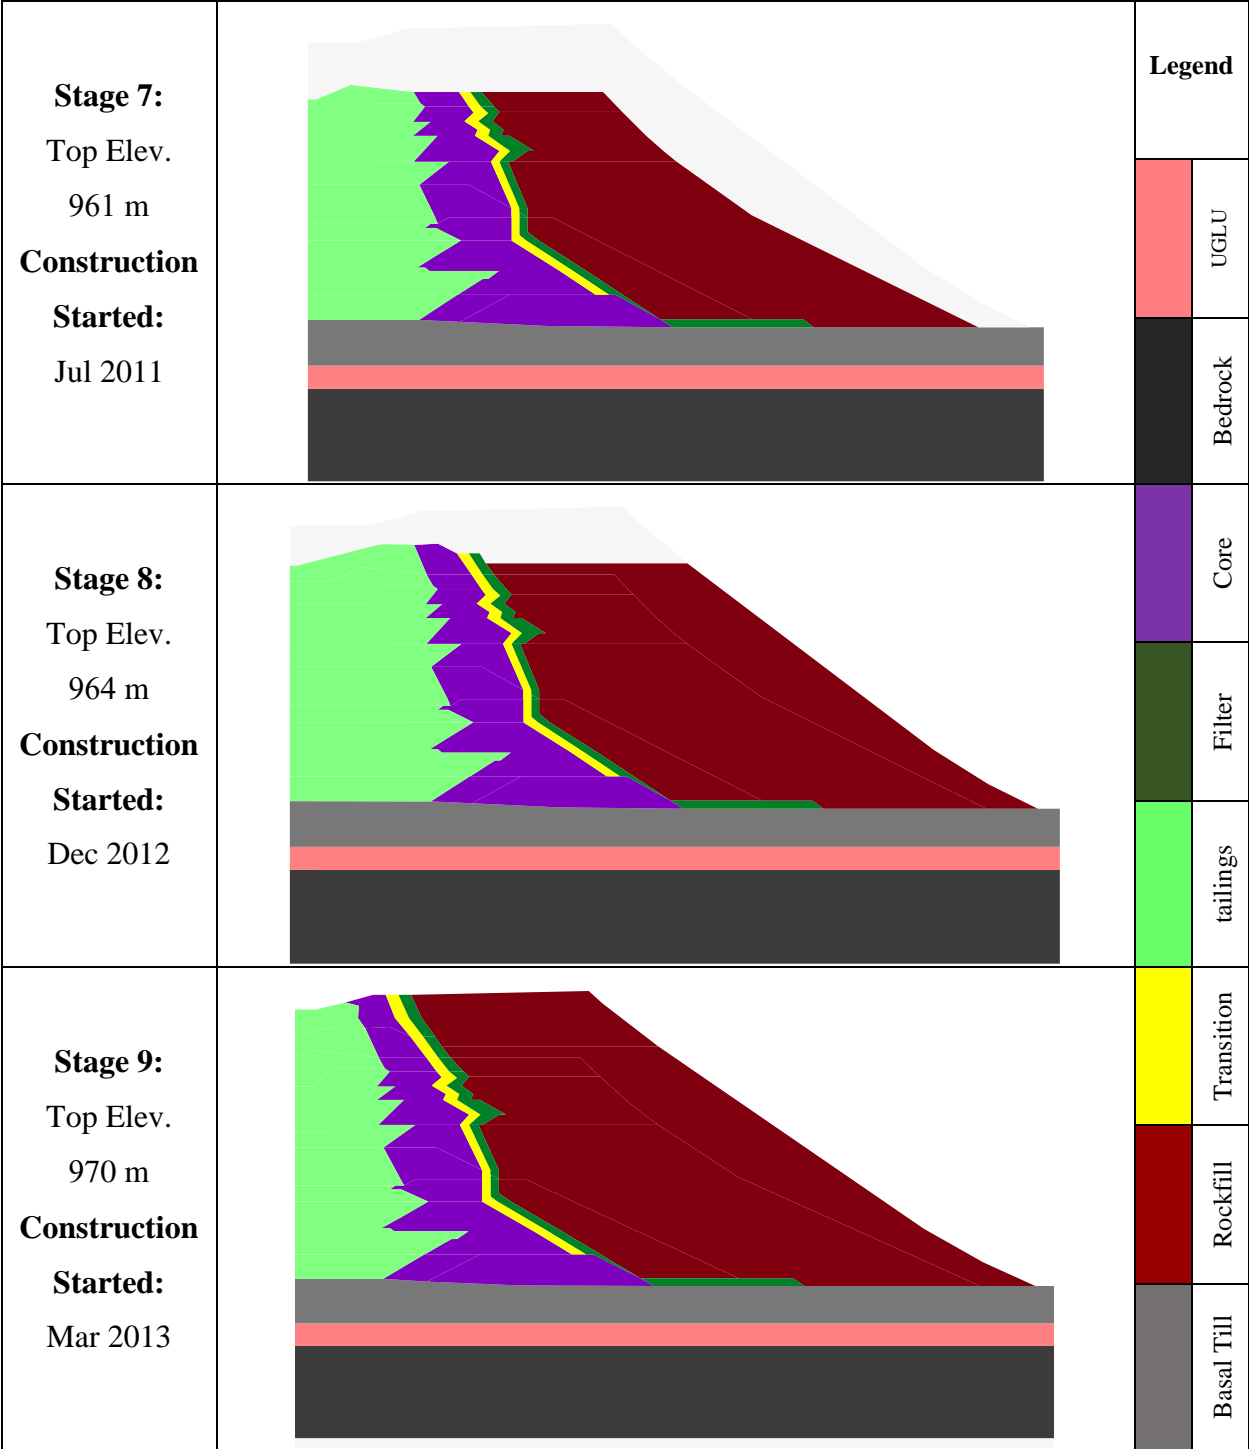
Figure 21: Development of Construction stages at MP-TSF (Completed)

Unlike other published designs, the current FEA considers a stage-by-stage development in the construction. Since 2005, the dam has been built in nine stages. The shape and the size of the dam section changed over this time. A qualitative diagram of stage-by-stage dam development is shown in Figure 21. To accommodate this temporal and spatial variation, appropriate boundary conditions were assigned in each stage of the simulation.

Stage	GLU in Mohr-Coulomb Model (C=0, $\Phi = 30^\circ$)	GLU in Undrained Shear Strength of 0.22
One	1.20	1.23
Two	1.19	1.23
Three	1.74	1.19
Four	1.60	1.16
Five	1.64	1.00
Six	1.63	1.15
Seven	1.59	1.05
Eight	1.32	0.97
Nine	1.35	0.97

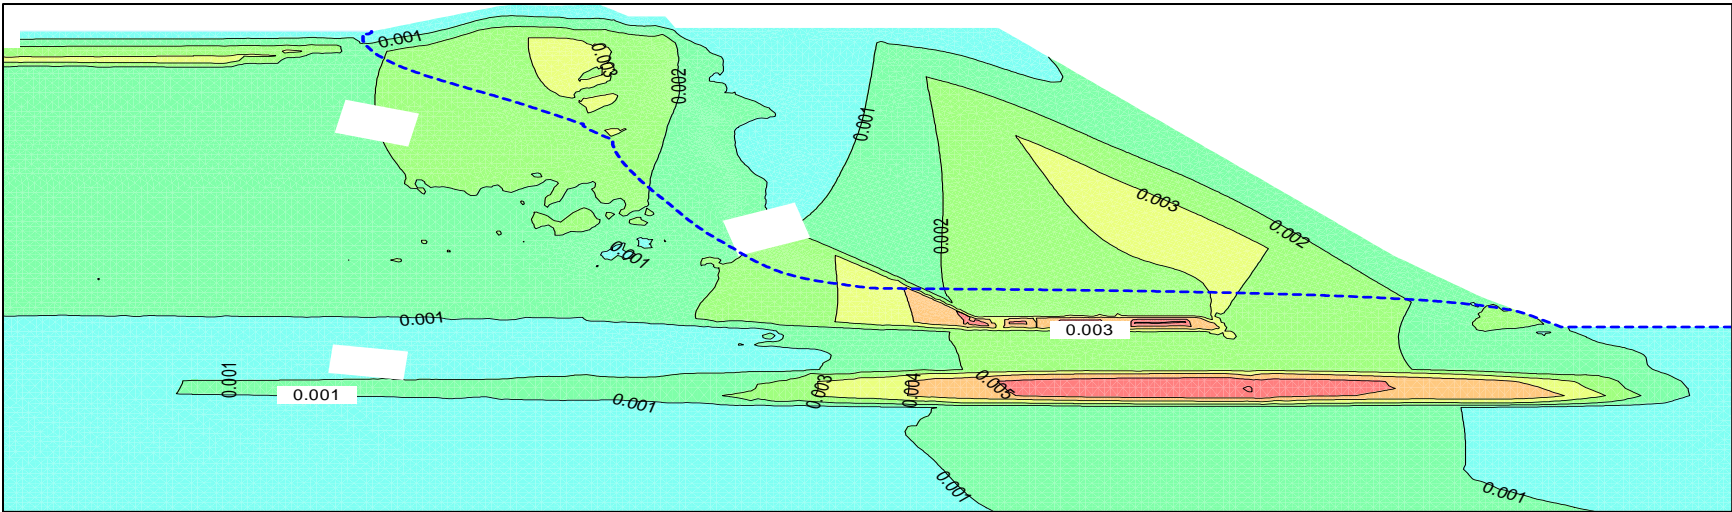
Figure 22: Maximum Shear Strain (ϵ_{max}) at 8th stage (ESA: Case 1)

Figure 22, 23, 26 and 27 show the maximum shear strain (ϵ_{\max}) contours of 8th and 9th stages of the construction in ESA for Case 1 and 2. These contour plots provide the extents and patterns of the maximum shear strains (ϵ_{\max}) when a new layer of embankment is constructed. Figure 24 and Figure 25 provide super-imposed graphs of shear strength and maximum shear strains of the GLU layer. These graphs provide clearer view of the maximum shear strain (ϵ_{\max}) and stress in the GLU layer.

It has been shown for Case 1 (higher relative stiffness) in Figure 24 that maximum shear stress was mobilized in the section is close to 300 KPa. For this stress, the amount of shear strain was as low as 0.8%. A new layer of construction in the 9th stage (Figure 25) increased the shear stress in the system; however, it did not increase the shear strain of GLU layer. For Case 2 (lower relative stiffness), the values of shear strain were not high (2% max) and the changes in shear strain from 8th to 9th stage were marginal (Figure 26 and Figure 27).

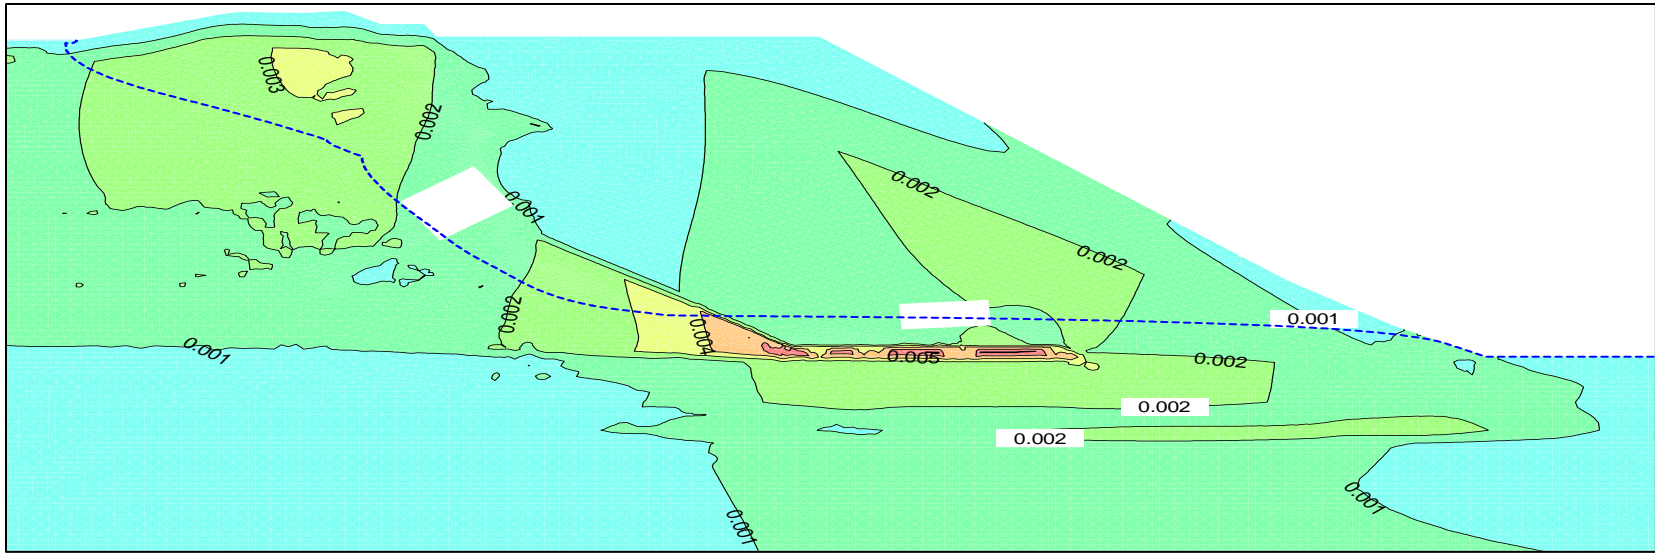
Figure 30: Maximum Shear Strain (ϵ_{max}) at 8th stage (TSA: Case 3)

Maximum shear strain (ϵ_{\max}) contours for 8th and 9th stages of construction for case 3 and 4 are shown in Figure 30, 31, 34 and 35. The patterns of shear strain changes were similar to that of ESA analyses; however, the values were different. Figure 32, 30, 33 and 34 provide superimposed graphs of maximum shear stress and maximum shear strain (ϵ_{\max}) to understand the shear strength mobilization within GLU layer.

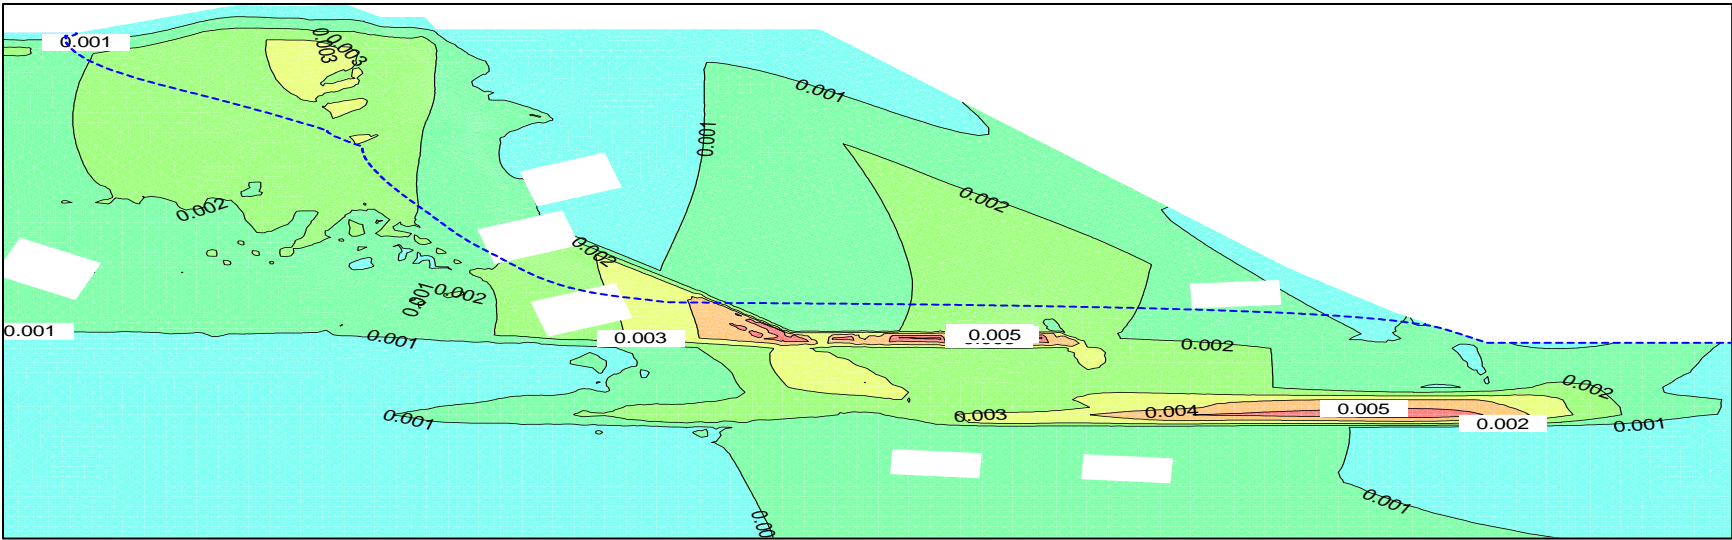
Figure 34 Maximum Shear Strain (ϵ_{max}) at 8th stage (TSA: Case 4)

The current study based on the finite element analysis (Analysis 4) had taken the same geometry and material strength properties for the failed section from Morgenstern *et al.* (2015); however, it also considered the ‘weak’ GLU layer in stress-strain condition. For Case 1 and 2, where the Effective Stress Analysis (ESA) was performed, adding a new layer of embankment in 9th stage did not change the maximum shear strain (ϵ_{\max}) by a significant amount (Figure 24, 22, 25 & 26). The mechanism was similar for case 3 of Total Stress Analysis (TSA), where the GLU layer was assigned with a high stiffness parameter (Figure 32 & 30). Instead, case 4 of TSA had a lower stiffness compared to the adjacent upper and lower ‘Till’ layers. This layer showed a significant increase in maximum shear strain (ϵ_{\max}) from 8th stage to 9th stage in this case (Figure 36 & 34).

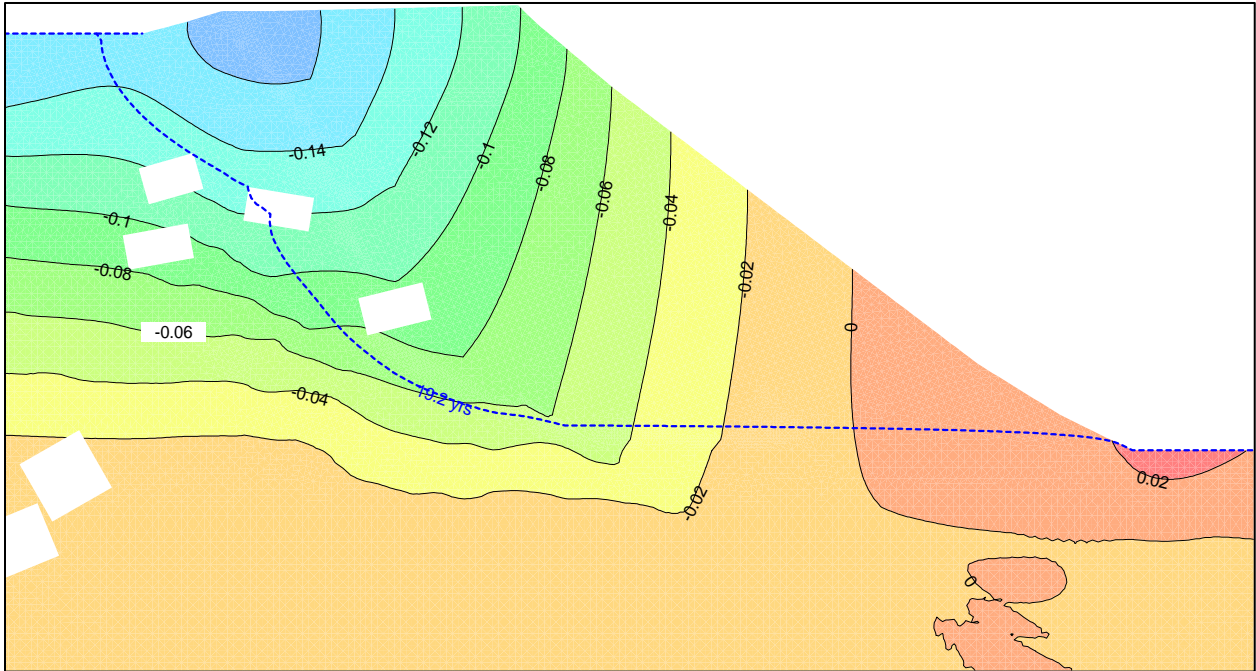
Figure 38: Global vertical deformation in meter after 9th stage (Case 4)

Deformation analysis provides overall deformation pattern of the structure. Deformation analysis was performed using SIGMA/W. Both vertical and horizontal deformations for case 4 (as this is the critical case with the lowest relative stiffness) are shown in Figure 38 and Figure 39 respectively. This low values of horizontal deformation indicates that the dam might have not failed due to horizontal translation. Figure 40 and Figure 41 show the comparison of vertical and horizontal deformation in 9th stage for all the cases. The comparison was done along the Embankment Setting Out Line (S.O.L.). S.O.L is an arbitrary reference line, usually the centreline of the dam core, from which horizontal measurements are determined (Vick 1990). In this dam, S.O.L is drawn along '0' (zero) m on X-axis (distance) in Figure 19.

The following four figures show that the maximum values of the deformation were not concentrated near the concerned GLU layer. This was true for all the cases discussed here.

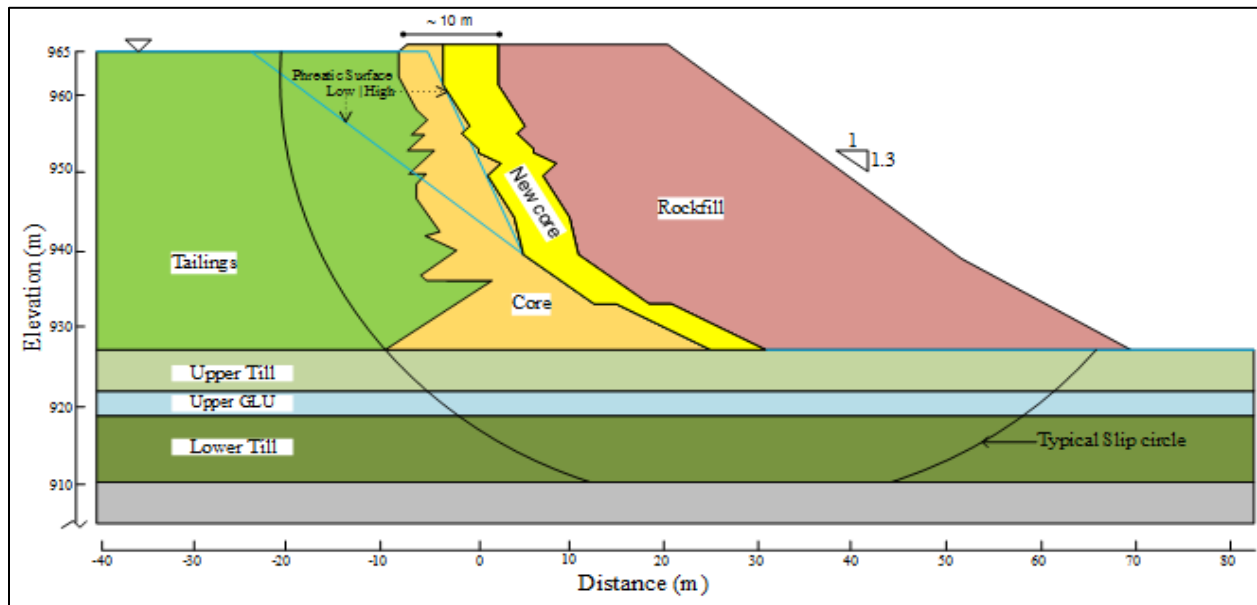
Figure 46: Perimeter dam with widened core of 10 m

Figure 47 indicates that maximum shear strain (ϵ_{max}) jumps from 1% in 8th stage to 8% in 9th stage. This excessive shear strain in 9th stage is sufficient to allow distortion and deformation in the foundation system. The failure mechanism in this case is similar to that of the original dam section. Thus, the dam remains unstable even thickness of the core material increases.

It was reported by Morgenstern *et al.* (2015) that the ‘core material’ crest width of the perimeter dam was approximately 4 m. That might have affected the overall stability of the dam. An increase in the crest width while keeping the core shape intact may have some effects on the dam stability. Figure 46 shows a modified dam section with a new crest width of 8 m. The FE analysis, however, shows that factors of safety obtained for the modified section did not increase. It remained close to 1 (one).

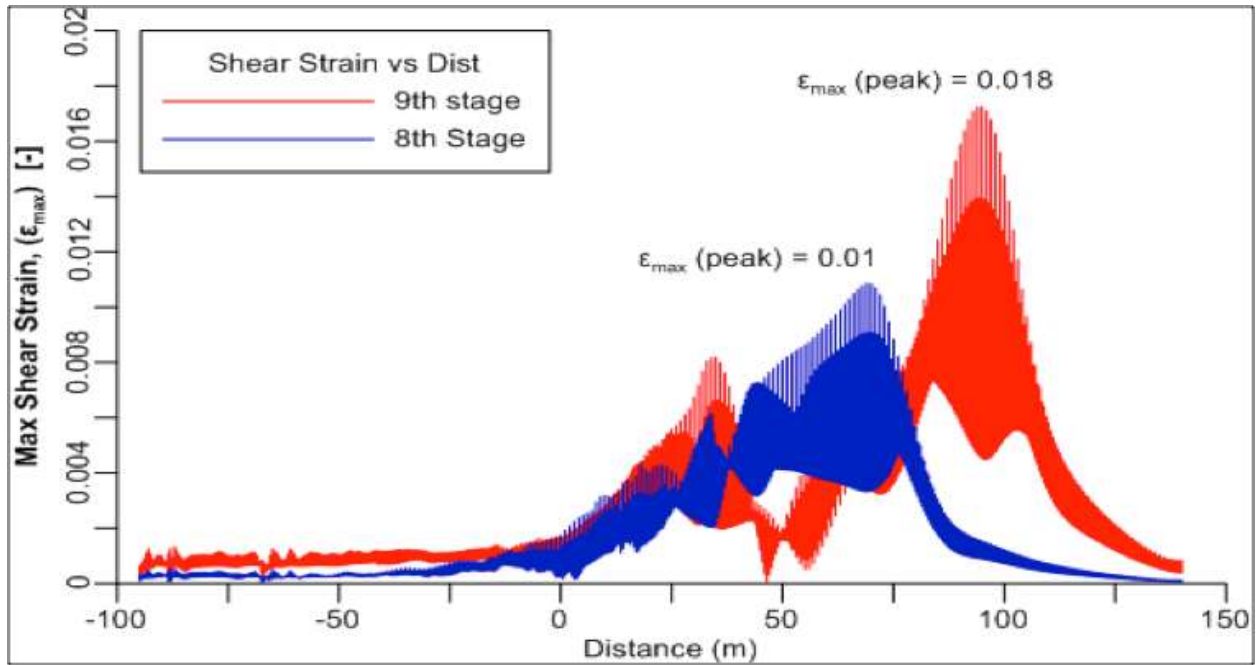
Figure 49: Maximum shear strain (ϵ_{max}) along GLU layer for 8th and 9th stage (new rockfill patch in downstream)

The differences in magnitudes of maximum shear strain (ϵ_{\max}) in 8th and 9th stages are negligible, 1.1% and 1.7% respectively (Figure 49). These shear strains are not sufficient to cause instability in the system.

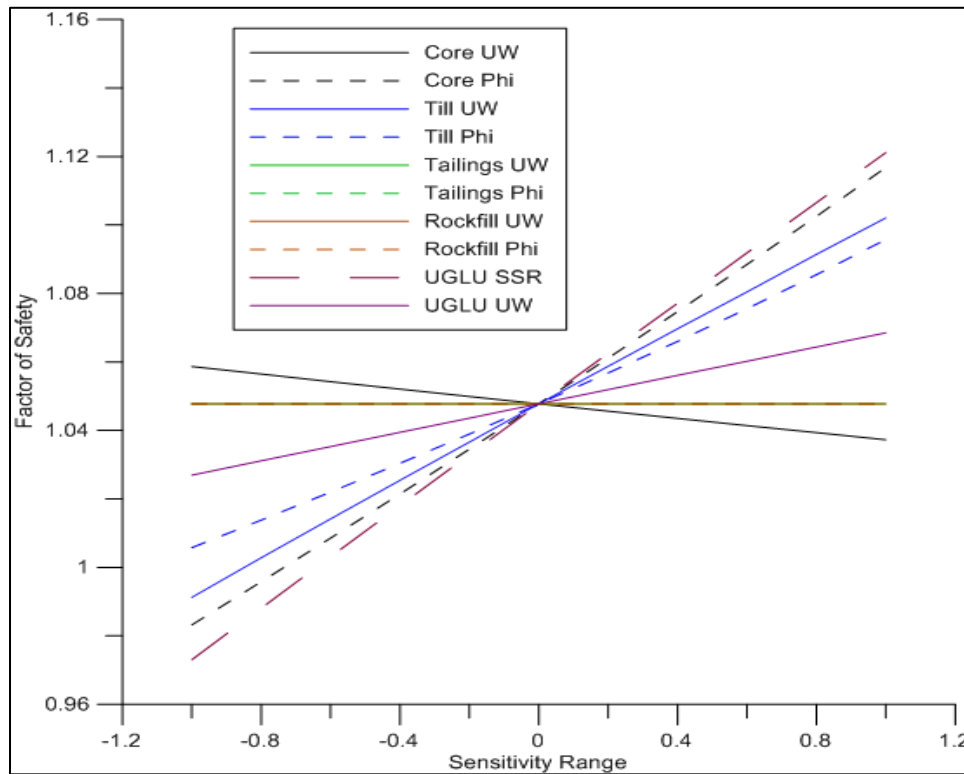
Figure 50: Sensitivity of the perimeter dam analysis (UW refers to Unit Weight)

The result is shown in Figure 50. From the graph, it is understandable that some parameters, like the angle of internal friction (Φ) of ‘core material’, UW of the Till (upper Till) and undrained shear strength (SSR) are more sensitive to changes than other parameters.
