**THE THERMOMECHANICAL RESPONSE OF STRUCTURAL TIMBER IN REAL  
FIRE EXPOSURES**

A DISSERTATION SUBMITTED TO THE FACULTY OF GRADUATE STUDIES IN  
PARTIAL FULFILLMENT OF THE REQUIREMENTS OF THE DEGREE DOCTOR OF  
PHILOSOPHY

GRADUATE PROGRAM IN CIVIL ENGINEERING  
YORK UNIVERSITY  
TORONTO, ONTARIO

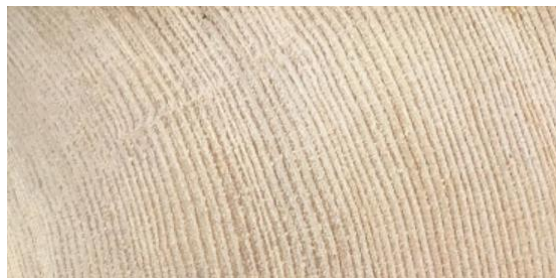
When trees grow, they grow outwards through the development of growth rings. New wood cells are produced on the inside of the bark, producing earlywood and latewood. Earlywood is developed earlier in the season (typically the spring), and usually has cells with large cavities and thin walls, while latewood (which develops later in the season) has smaller cavities and relatively thicker walls [14]. Earlywood is lighter weight and weaker than latewood, attributed to the higher density of latewood [14]. In seasonal climates, earlywood and latewood will be different colours (with the latewood being darker than the earlywood), allowing the approximate age of the tree to be counted as one year per growth ring. Trees may grow more than one growth ring per season if the growth cycle is interrupted (by droughts or other reasons) or may not have any defined growth rings (due to species or climates with indistinct seasons). Factors such as the speed of growth may have an effect on the size of growth rings and density of the wood, however, researchers have not unanimously agreed on this correlation [15].

Figure 2.2 Growth rings as seen on a piece of Pine timber (author's photo).

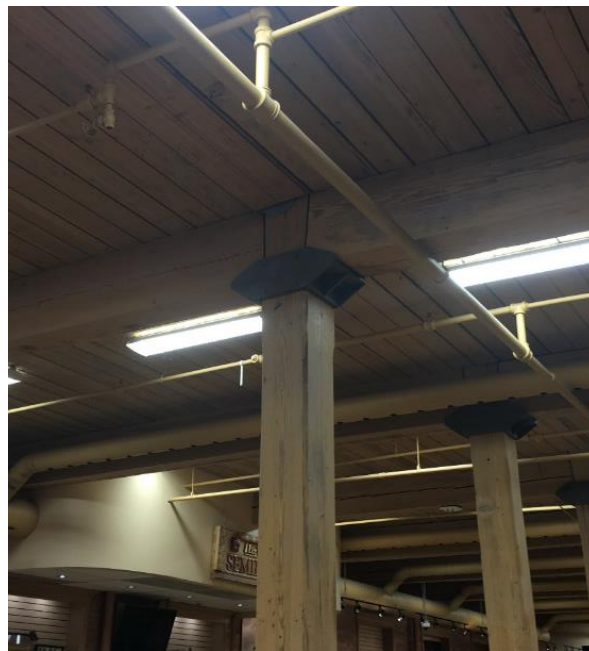
Prior to the use of documented encapsulation methods, timber buildings have long been left exposed. An exposed heritage timber building (currently used as a retail store) is seen in Figure 3.3. In the late 18<sup>th</sup> century, a group of well regarded architects formed a committee (known as the Associated Architects) to deal with the fire problem that they believed was disrupting London, UK, and other cities [41], this committee was formed in response to a recent theatre fire. This association would be later viewed as the precursor to Royal Institute of British Architects (RIBA). Led by Henry Holland, they aimed to identify the causes of the recent conflagrations, as well as methods of preventing similar fires from occurring in the future. The Associated Architects, as they called themselves, described and instructed the use of metal plates and plasters for use as fire protection encapsulations.

Figure 3.3 An exposed timber building, constructed in 1902 as a warehouse in Toronto, Canada (author's photo).

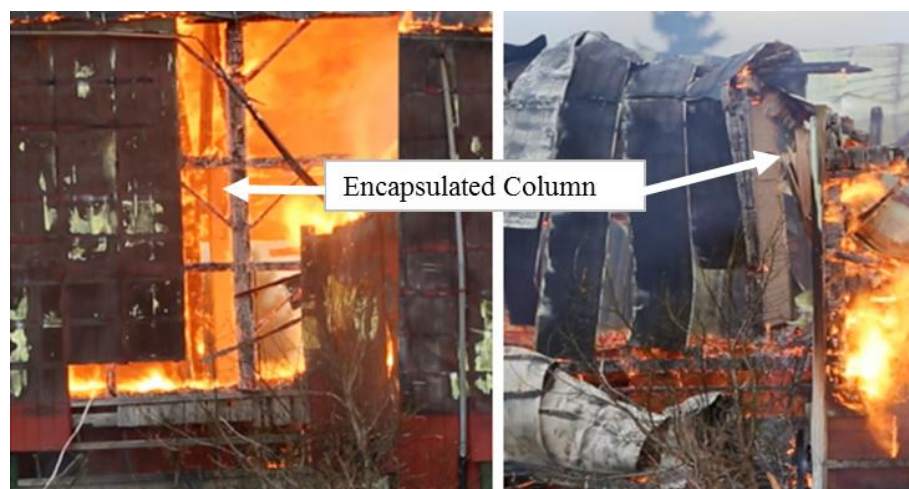
Figure 4.13 Images of Column 1 during field test (left) prior to structural collapse (right) post flashover event.

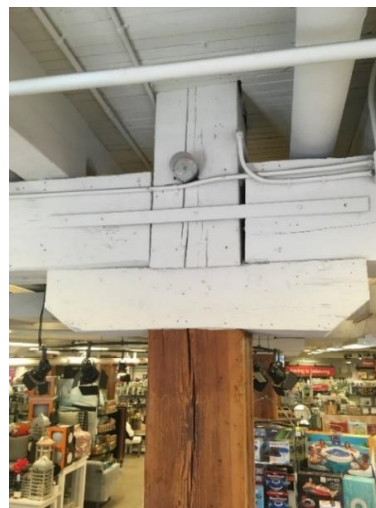
Figure 5.1 a. A contemporary timber structure; b. a historic timber assembly (author's photos).

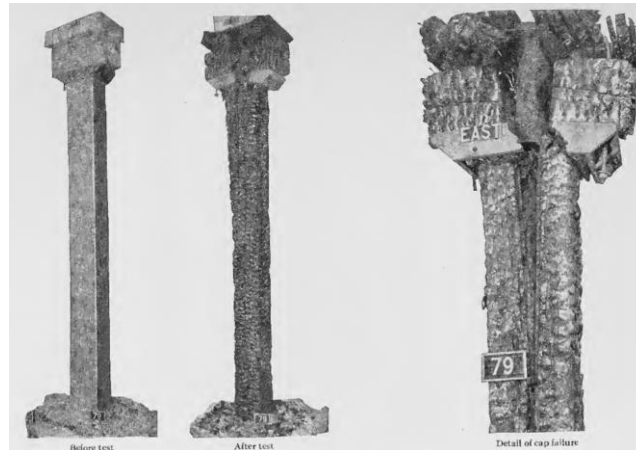
Figure 5.4 Qualitative results of the fire testing of one of the specimen, an unprotected longleaf pine column with a cap and pintle bearing (from [75]).

The time to failure of these columns was reported in the results and ranged from 35-50 minutes for the exposed columns and up to 2 hours and 15 minutes for the encapsulated columns. The failure mode of these columns was due to deformation at the steel or cast-iron caps. One of these columns may be seen, before and after testing, in Figure 5.4. The study outlines a number of limitations on its findings, including that the moisture content of the timber species was not comparable (and as a result, a comparison could not be made between the tests of the two timber species). Typically, the columns with the cast iron caps withstood longer than those with the steel caps. From these tests, the Bureau of Standards has offered a Fire Resistance duration for each of

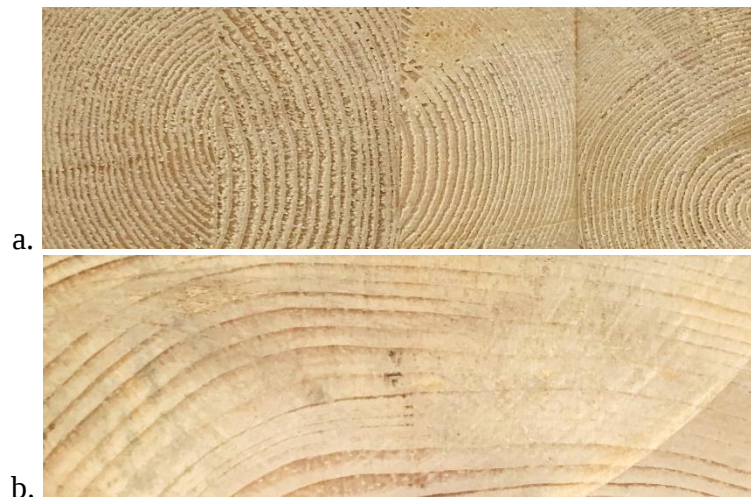
Figure 5.5 Cross sections of showing the growth ring width of, a. contemporary Glulam and b. historic timber, from a building constructed in the 1840s (author's photos).

Historic timber differs from contemporary timber for several reasons. Timber is a polymer, and it cannot be assumed that all polymers within a group (including wood) will act identically in fire [77]. Historic timber was produced from trees that were grown hundreds of years ago. Ancient timber growing practices may be different than contemporary growing practices, which may affect properties inherent to the timber such as density and growth ring width [78, 79]. An example of this is seen in Figure 5.5. For the particular samples shown in Figure 5.5, the contemporary timber shows more uniformity in its growth rings, whereas the historic sample has more variation. Furthermore, contemporary timber often frequently uses adhesives and other additives which may also impact the fire performance of the timber. Adhesive lines in the contemporary Glulam are seen as vertical lines holding together the wood laminates in Figure 5.5a.

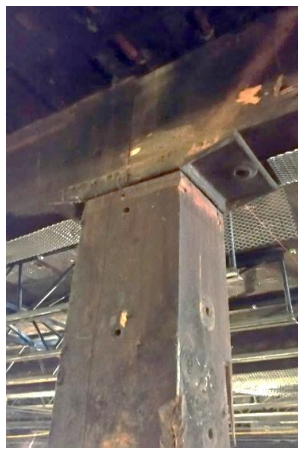
Figure 5.6 The timber column in the basement of the structure before removal.

The structure used large timber beams and columns connected by a cast iron cap, which is seen in Figure 5.6. Several timber members were (carefully) removed from the structure by the building owner to accommodate an adaptive reuse project, and the timber samples used in this research were sourced from one of these columns (originally located in the basement). The dimensions of the column were 240 x 290 mm. All timber described as ‘Column’ indicates that it is timber from one of the columns within the industrial mill building. The materials were wrapped in plastic to allow slow acclimatization to new laboratory conditions.

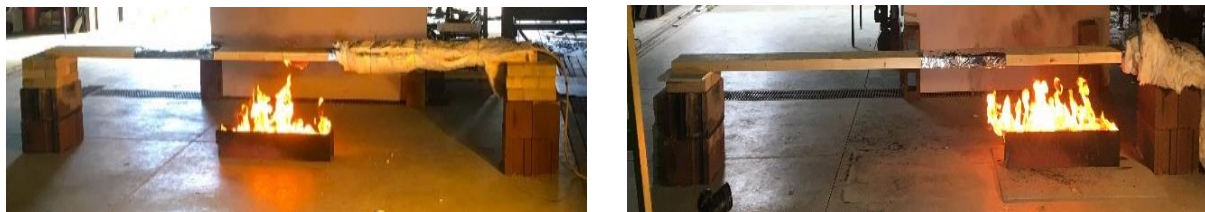
Figure 6.1. Test setup of the heating portion of the experiment for the moment region (left) and the shear region (right).

A custom experimental procedure was designed for the fire response tests conducted. This testing consisted of localised fire exposure (shear and moment regions of the specimens) followed by mechanical testing of the beams afterwards. The first phase test setup, consisting of a single beam locally exposed to a fire is shown in Figure 6.1. The fire for each test was fuelled by 1 litre

The fire burned for approximately 5 minutes, producing a peak surface average temperature of 900°C on the exposed beam. The heating configuration was determined through a series of test burns. The beams were exposed to fire twice; once along each of the depths (sides) of the beams (the beams were flipped). As the purpose of the pool fire procedure was to create a repeatable damage state, the beams were protected outside their fire exposed regions to inhibit flame spread for a more quantifiable damaged area. This was done by wrapping the beams in aluminum foil in the regions where no char was desired (seen in Figure 6.1). Insulation was also used to protect thermocouple wires running from the data acquisition unit to the pool fire (also seen in Figure 6.1). No water was needed for extinguishment as the beams auto-extinguished once the kerosene fuel was consumed. The fire is to be considered a short period of real fire impingement on a structural element. The fire exposure was designed as non-standard to explicitly induce a controlled and quantified amount of charring on the samples from test to test.

Of the charred beams, two beams were charred across a 1 m length directly in the center of the beam, and three were charred across a 1 m length on one end, beginning 270 mm from the edge of the beam (Figure 6.1). The purpose of these locations is that in the next phase of testing (mechanical loading through four-point bending), the centre of the beam would be in the region of highest moment, and the side of the beam would be in the regions of constant (highest) shear. This heating configuration had negligible differences in the amount of char observed, even along the top and bottoms of the beams (5 +/- 1 mm at three locations on each beam equally spaced and across the depth). Aluminum foil was wrapped around the beam immediately adjacent to the intended char zone to limit the radiant heat and flame spread to other parts of the beam. When the pool fire burned out, the beams were left to auto-extinguish. Since this happened immediately, no water was used for extinguishment. This test setup allowed for two-sided heat exposure.

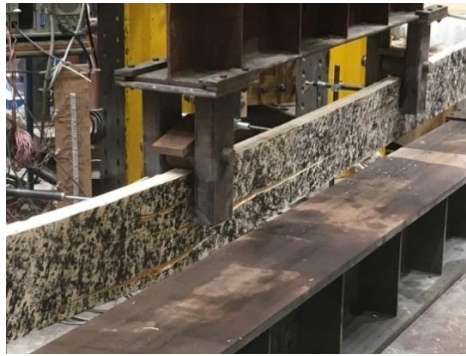
Figure 6.3. Failure mode of a Glulam undamaged control beam.

As they were mechanically loaded, the beams primarily failed within the moment region, along both adhesive bond lines and finger joints. The failure mode can be seen in Figure 6.3, where the failure originated along the adhesive bond lines within the moment region.

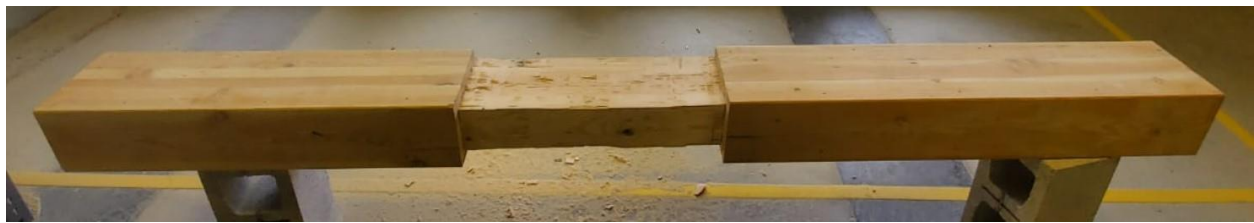
Figure B.1 Carved member before repair.

The carving procedure consisted of using a saw to create guides of a specified depth along the damaged region of the members. The majority of the damaged material was then removed with a chisel. A belt sander was then used to create a smooth and uniform surface, precisely to the desired depth. A carved member before repair is seen in Figure B.1 (where the sides of the member are parallel to the floor, and the bottom is towards the camera).

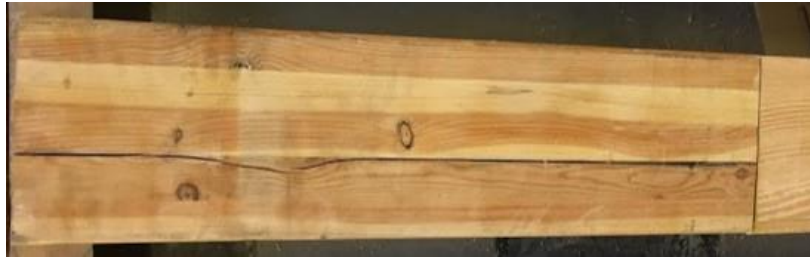
Figure B.8 Side of Member 5.

The failure load of Member 5 was 57% of the control failure load. This is less than the capacity of the other repaired member of the same size (Member 3 that failed at 66% of the control load). One factor that could have played into the low failure load of Member 5 (relative to Member 3) was cracks that were present along the side of the member (primarily along the adhesive lines). These are seen in Figure B.8 and were present after the fire exposure of the member (before any mechanical loading). While this crack or delamination may have a different effect on the structural performance of the member if loaded in compression (as is typically done for Glulam members of 16c-E stress grade, where cracking can impact the moment of inertia reducing buckling capacity of some columns), it will also impact the member tested in bending. The presence of these cracks may have reduced the capacity of the member and made it more difficult to achieve composite action. The effect of cracks and delamination in Glulam members is also something that needs to be considered with regards to repair. Cracks occur in many timber structures, both historic structures as well as structures that were constructed relatively recently. Cracking and delamination in the column of a contemporary timber structure in Toronto, Canada is seen in Figure B.9, where the structure was constructed in 2015, with the photo taken four years later. The column seen in Figure B.9 shows both delamination along the adhesive lines as well as within the timber itself. The presence of cracks and delamination in timber members complicates both the structural and fire performances of the member, as well as the repair procedure. The effect of cracks and delamination in timber should be addressed in future research, with regards to the

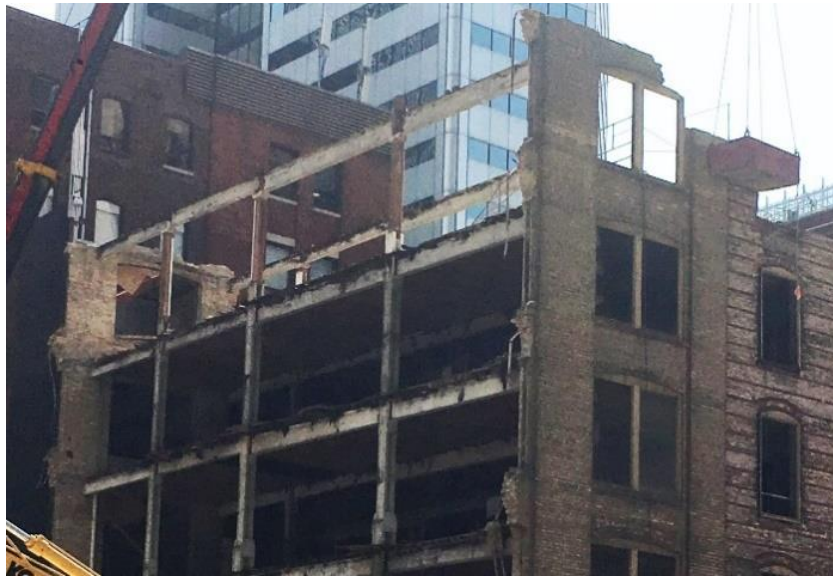
Figure C.2 Material acquisition from industrial building in Toronto, Canada (by permission).

The timber material was collected from a former industrial building in Toronto, Canada, built in 1905. The material acquisition occurred during the partial deconstruction of the building to accommodate a new high rise on the site that will incorporate a small portion of the original façade. The building was a 6-storey brick masonry structure with interior elements made of timber and steel, the timber elements tested herein were found on the upper (5th and 6th) floors as seen in Figure C.2. Its original use was industrial but had been converted to commercial office space

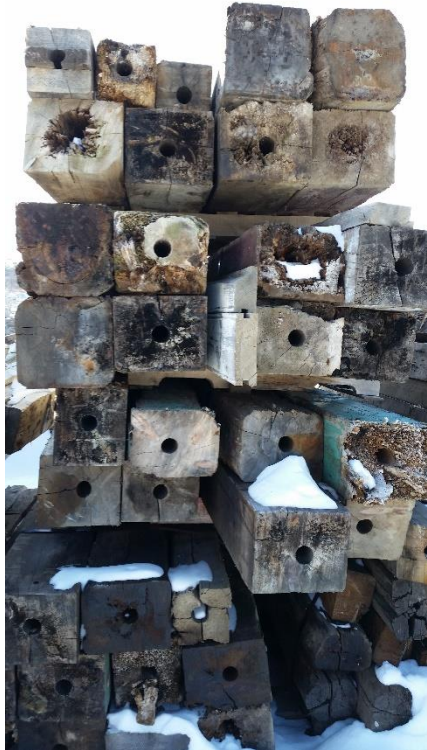
Figure C.3 Improper storage of heritage timber materials (by permission).

from moisture and/or pests and become structurally compromised after removal. Figure C.3 shows unsuitable storage of materials of a different site found in Canada where the authors rejected other samples. These considerations exemplify the difficult to study nature of procuring in-situ testing of older material specimens and the need to provide guidance on material collection for other practitioners.

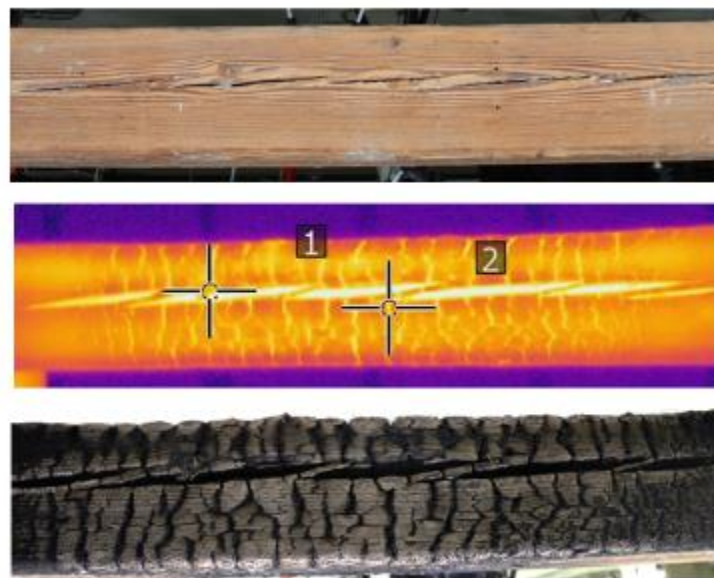
Figure C.7 Side A crack progression before (top) and after fire (middle and bottom) on Heritage 2 (identifiable markings were recorded temperature markers).

In terms of crack expansion during testing, Heritage 1 initially had a crack on the soffit of 6.2 mm in width, which grew to 12.6 mm after fire exposure, meanwhile Heritage 2 had a crack on side A with an initial width of 5.4 mm and a final width of 10.4 mm. In both these cases, the crack width more than doubled during the thermal exposure. Moreover, Heritage 2 had only very small initial cracking along side B, and by the end of the thermal exposure one crack grew from less than 1 mm in width to 11.5 mm in width. This expansion over time is plotted in Figure C.11 and shows that the crack expansion occurs relatively linearly during the heating phase (the first 30 minutes), and the expansion rate slows to near zero during the subsequent 30 minute cooling phase. Figure C.12 shows the capabilities of the narrow spectrum illumination technology allowing for this analysis, as the images seen would otherwise be obscured by the presence of flames. The crack that is shown in Figures C.11 and C.12 that began at less than 1 mm is depicted as it exemplifies the trends seen in other cracks (i.e., it was the crack with the greatest change in width, allowing for trends to be more clearly observed). The lack of pre-existing radial cracks indicates minimal exposure to severe moisture changes (and therefore shrinkage) before thermal exposure, unlike the opposite side of the member which had not experienced previous shrinkage cracks, therefore there was more potential for shrinkage crack formation during fire test. While this crack widened more than 10 times its initial size, versus the doubling of the existing cracks, the final crack widths after exposure were comparable, within 9% difference of each other.
